**BUNNELL-LAMMONS ENGINEERING, INC.**  
GEOTECHNICAL, ENVIRONMENTAL AND CONSTRUCTION MATERIALS CONSULTANTS

# LAKE JUNALUSKA DAM BRIDGE EVALUATION

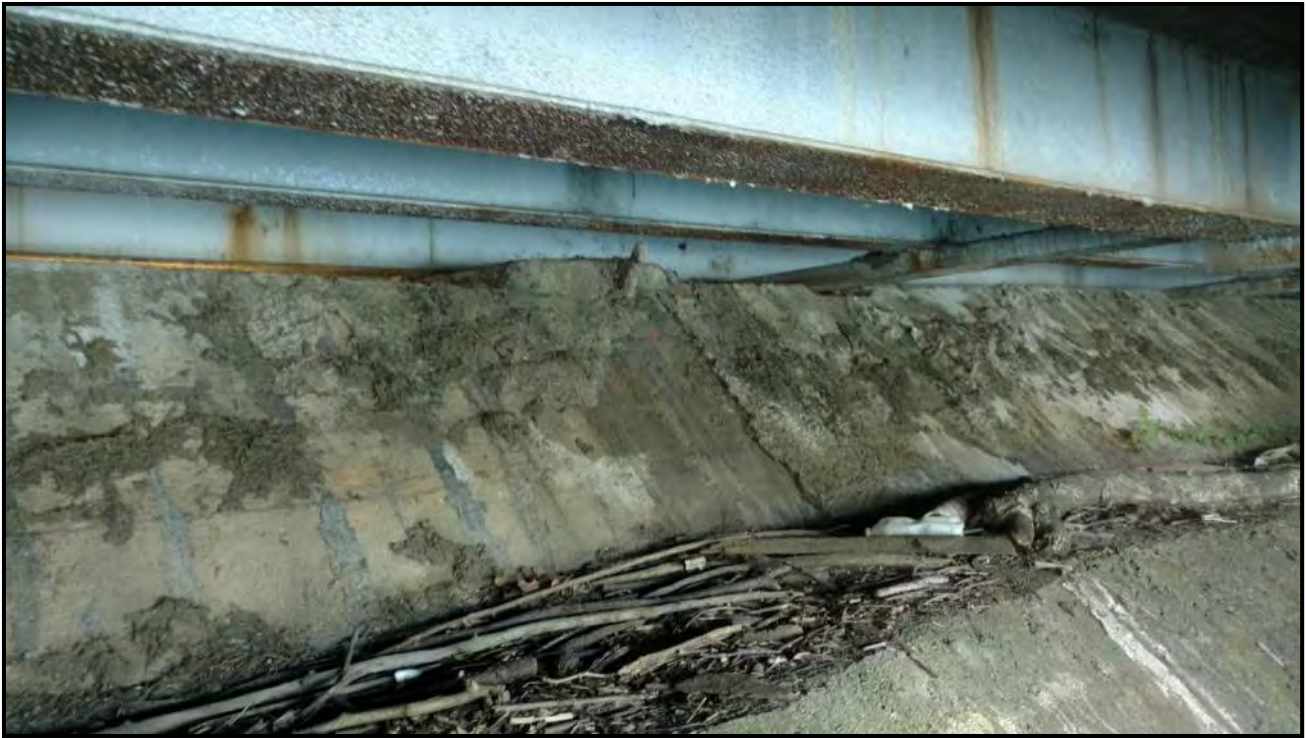
**Photograph 1:** Missing intermediate concrete abutment for 8" bridge girder support at Bay M.

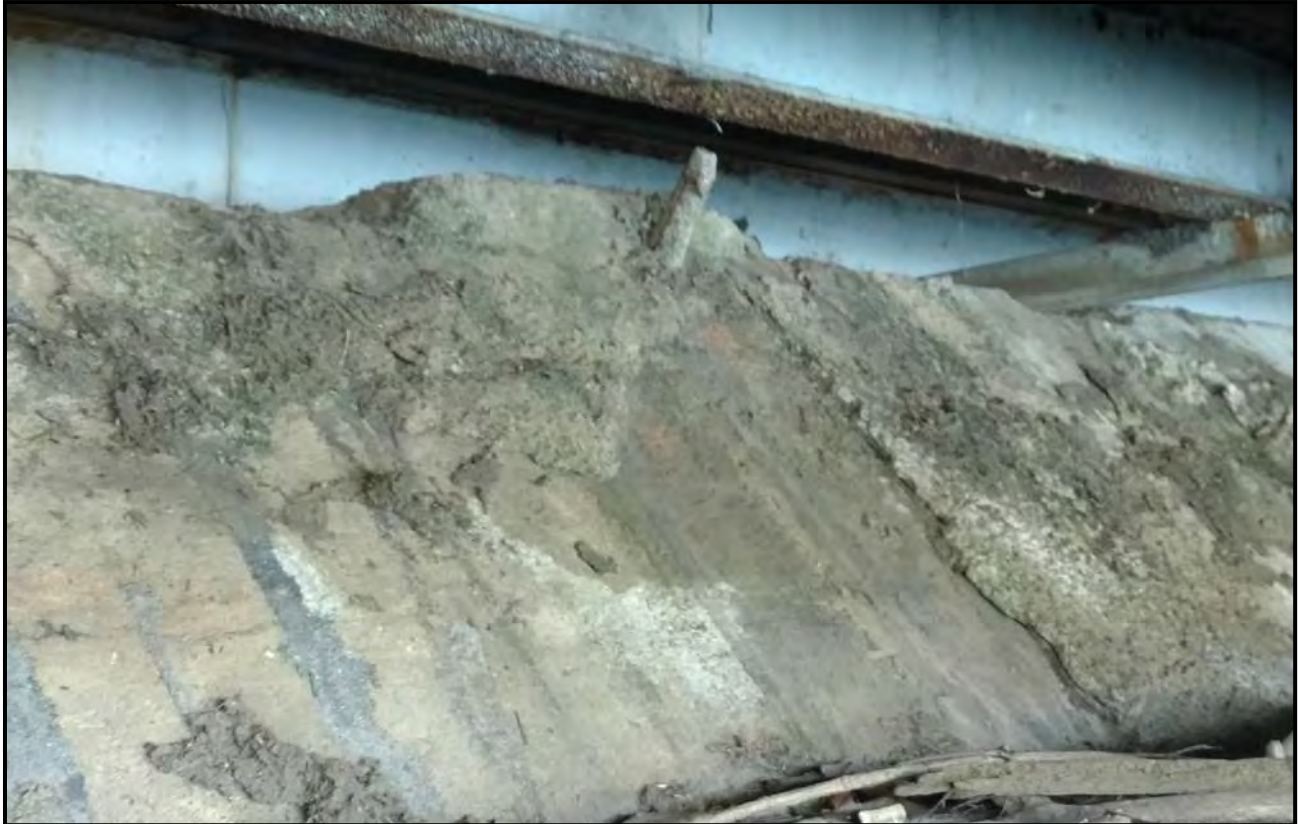
**Photograph 2:** Missing intermediate concrete abutment for 8" bridge girder support at Bay M.

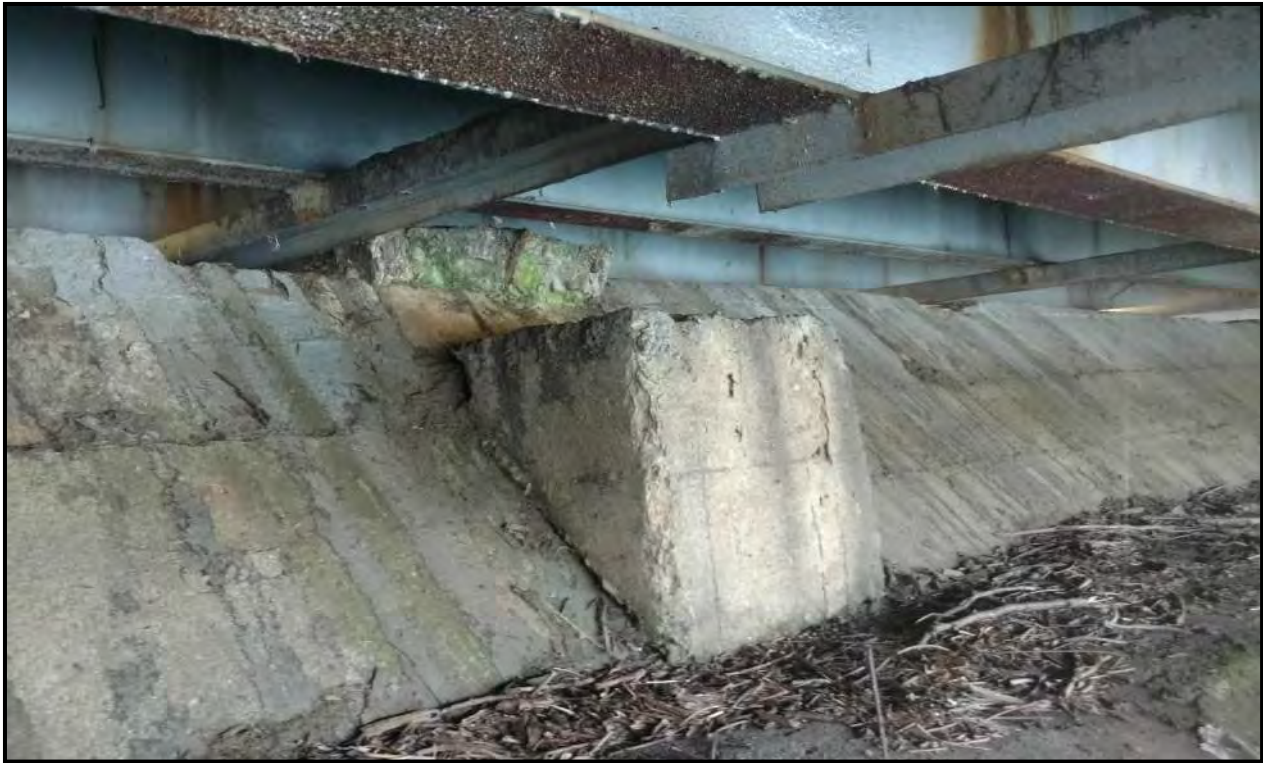
**Photograph 3:** Damaged intermediate concrete abutment for 8" bridge girder support at Bay K.

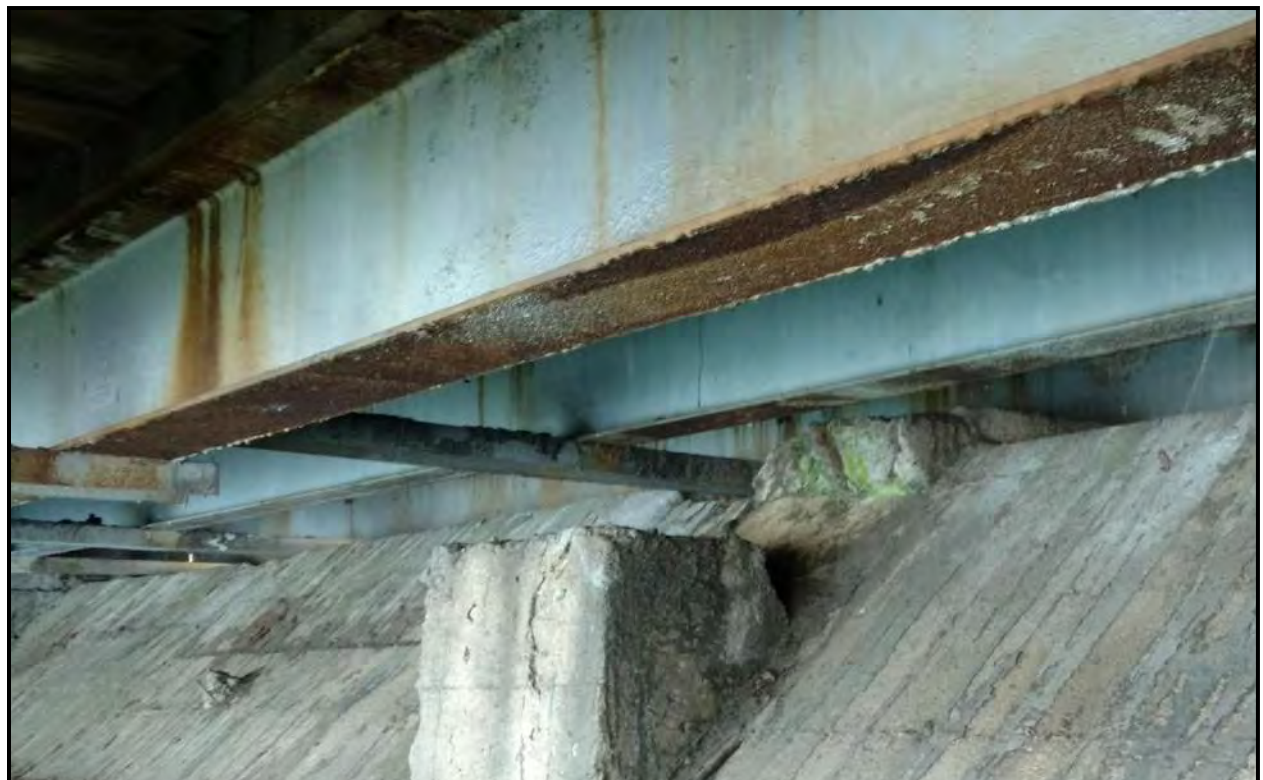
**Photograph 4:** Damaged intermediate concrete abutment for 8" bridge girder support at Bay K.

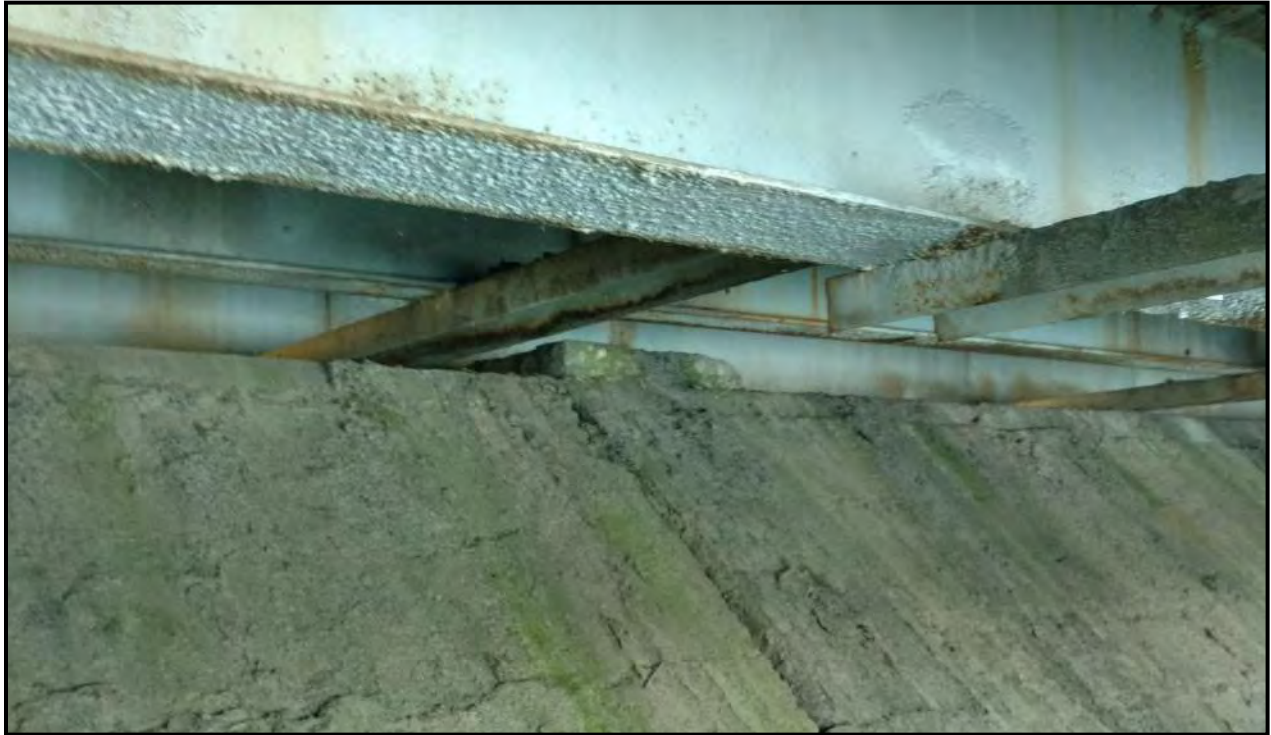
**Photograph 5:** Damaged intermediate concrete abutment for 8" bridge girder support at Bay B.

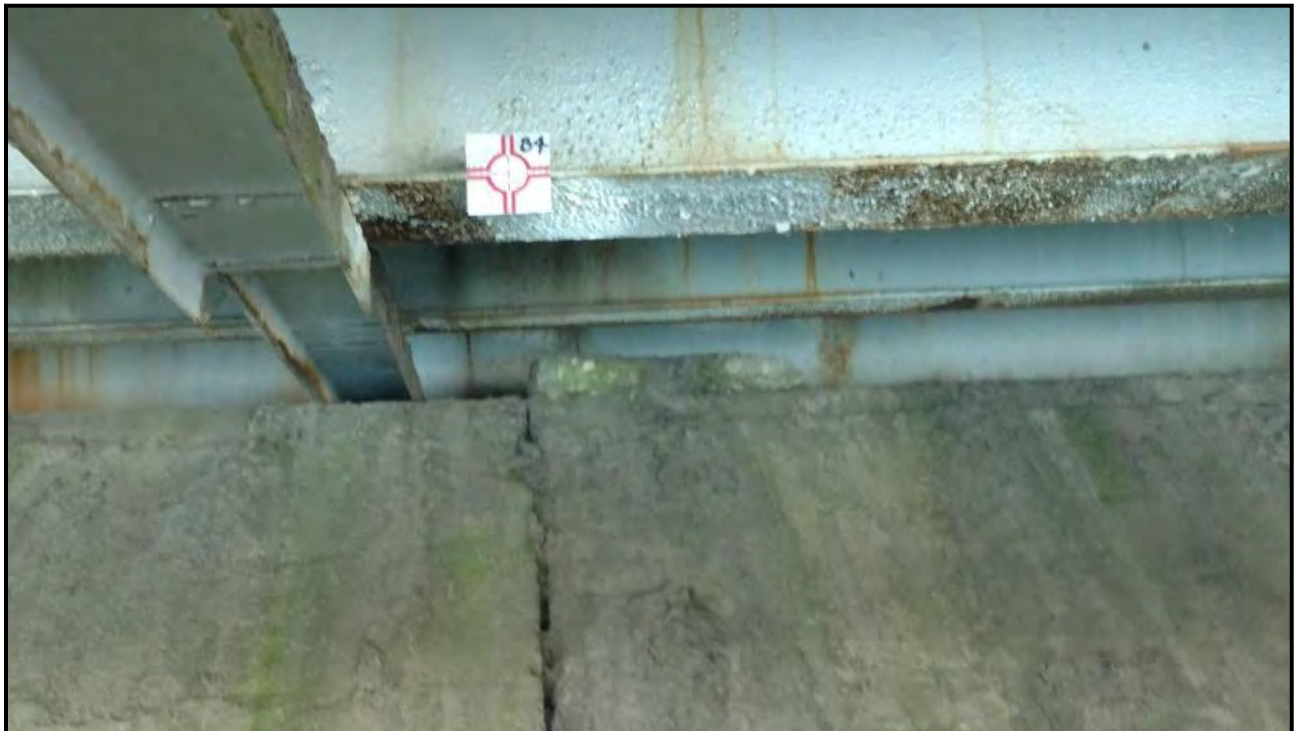
**Photograph 6:** Damaged intermediate concrete abutment for 8" bridge girder support at Bay B.

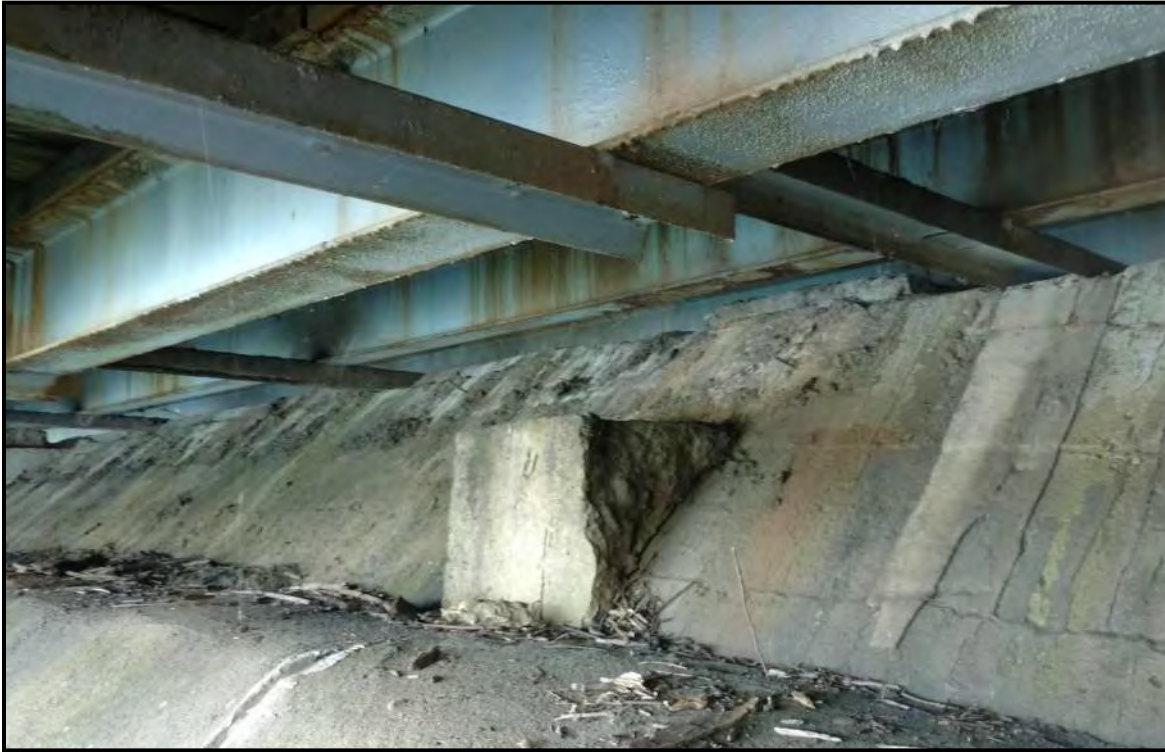
**Photograph 7:** Damaged intermediate concrete abutment for 8' bridge girder support at Bay A.

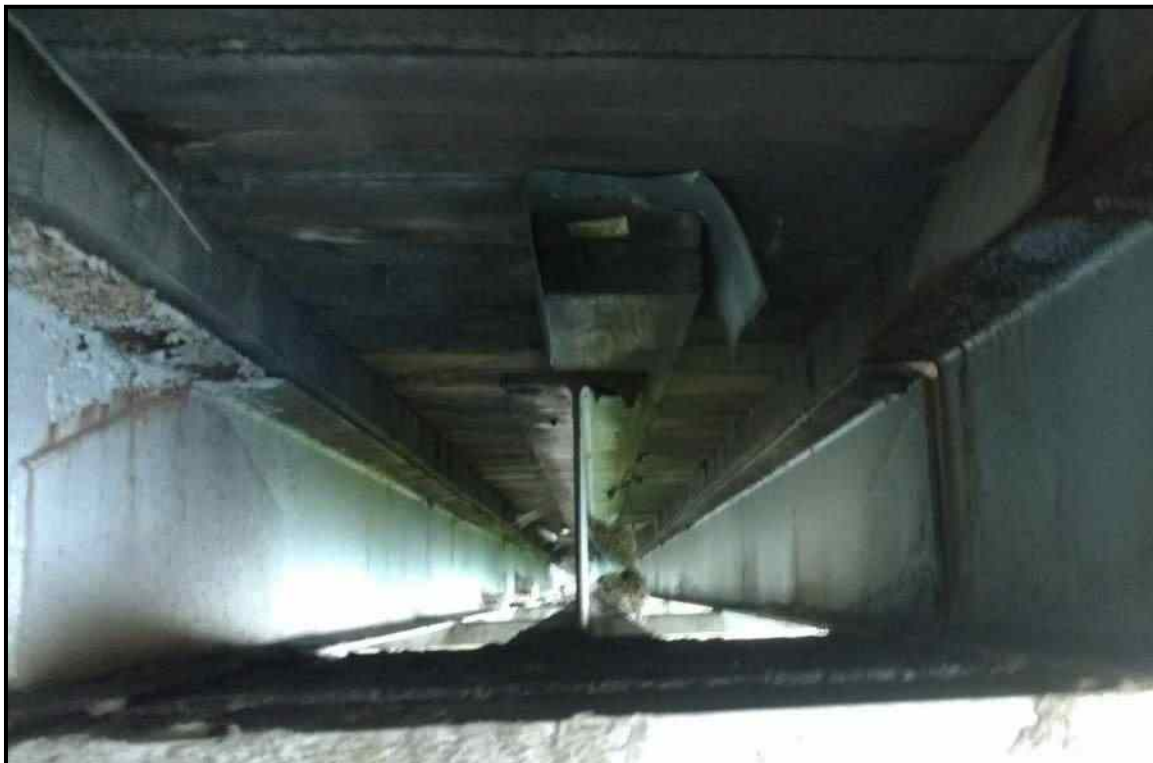
**Photograph 8:** Insufficient connection of supplemental bridge girder to bridge deck.

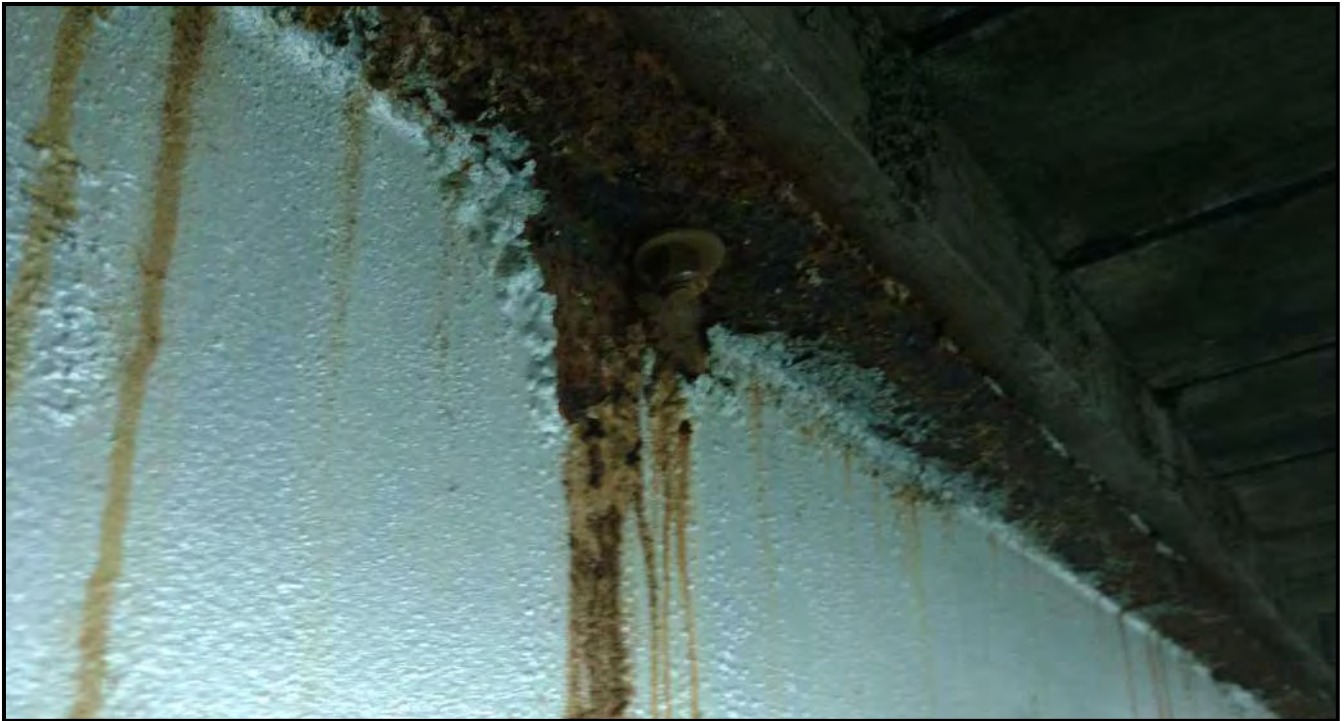
**Photograph 9:** Severely corroded bolted connection and top flange of bridge girder in Bay N.

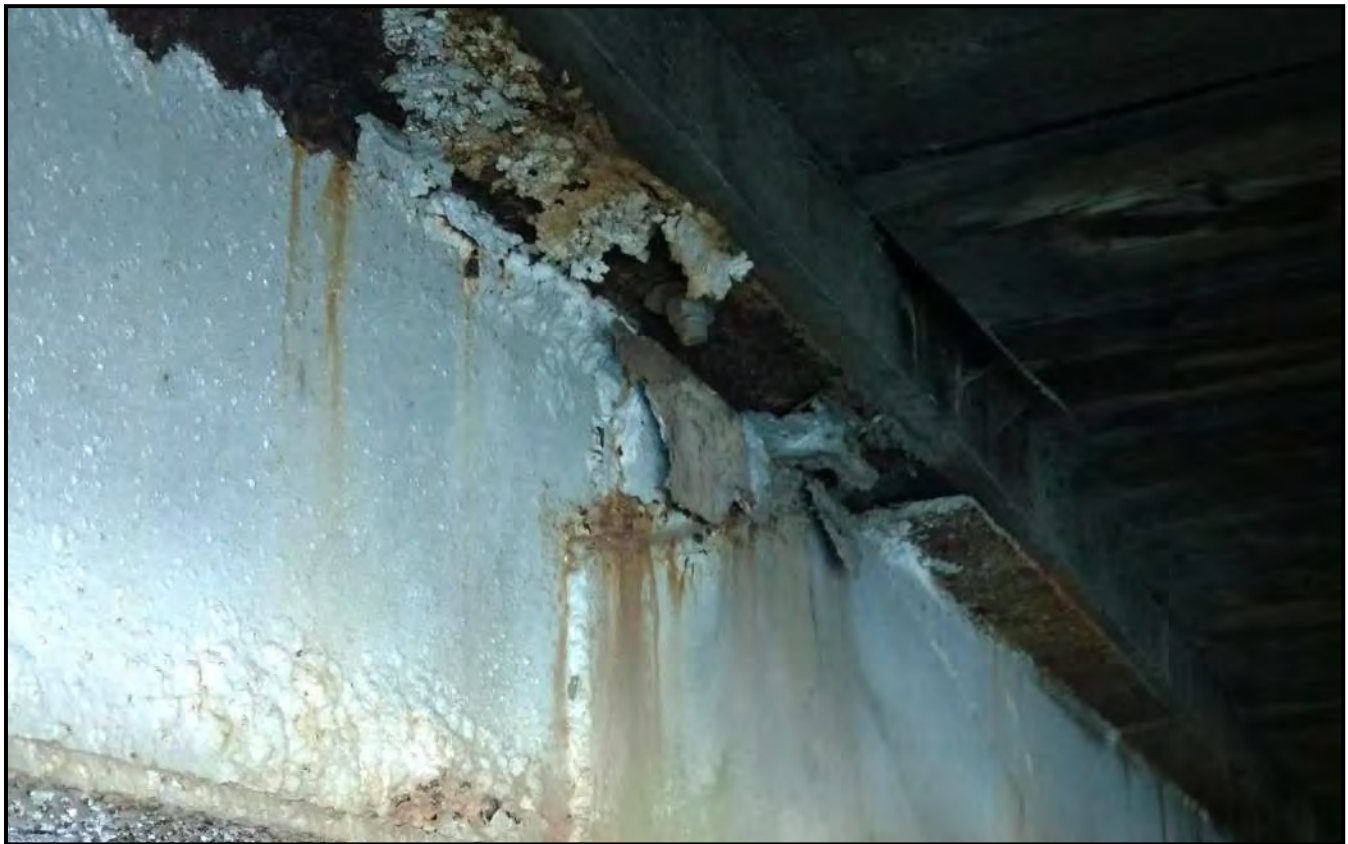
**Photograph 10:** Severely corroded bolted connection and top flange of bridge girder in Bay M.

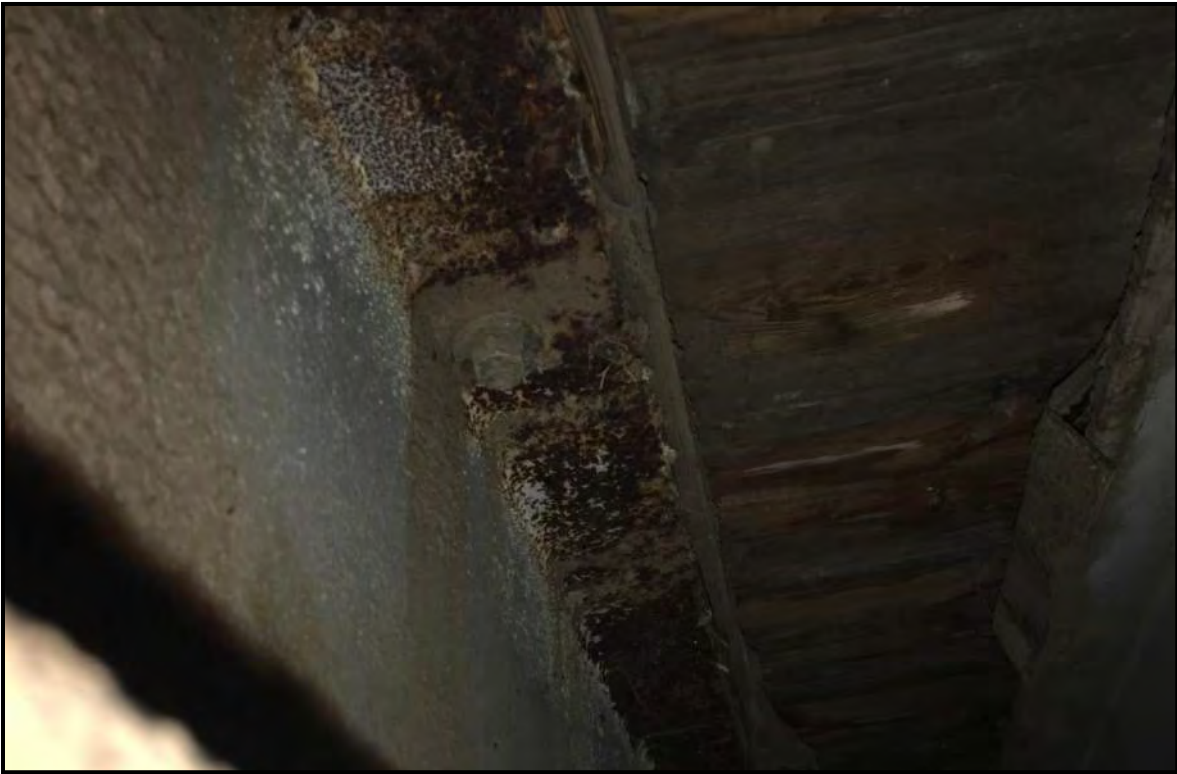
**Photograph 11:** Severely corroded bolted connection and top flange of bridge girder in Bay Q.

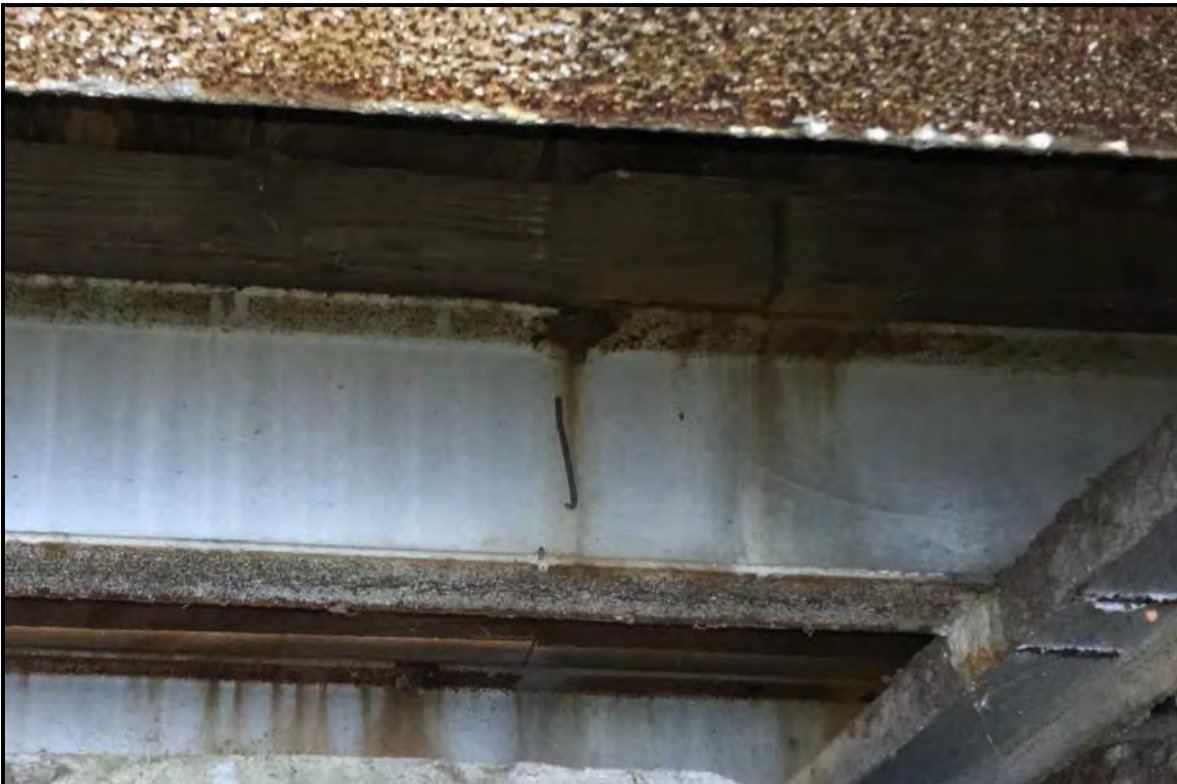
**Photograph 12:** Severely corroded bolted connection and top flange of bridge girder in Bay K.

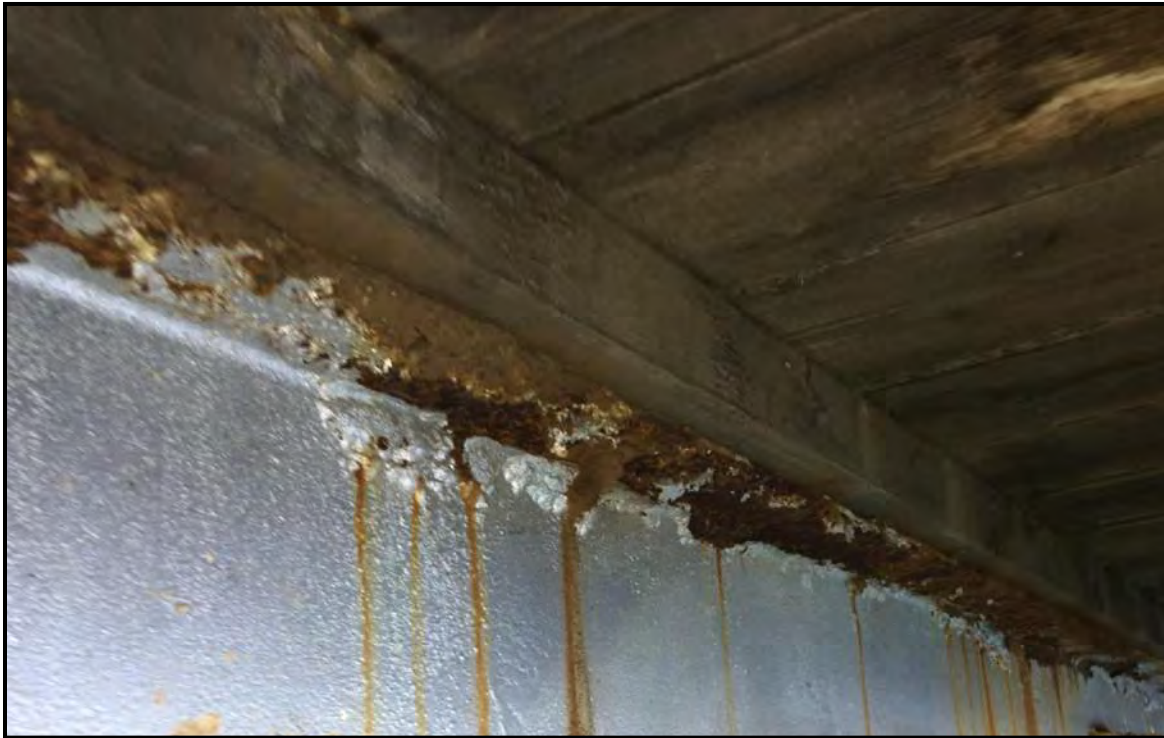
**Photograph 13:** Severely corroded bolted connection and top flange of bridge girder in Bay M.

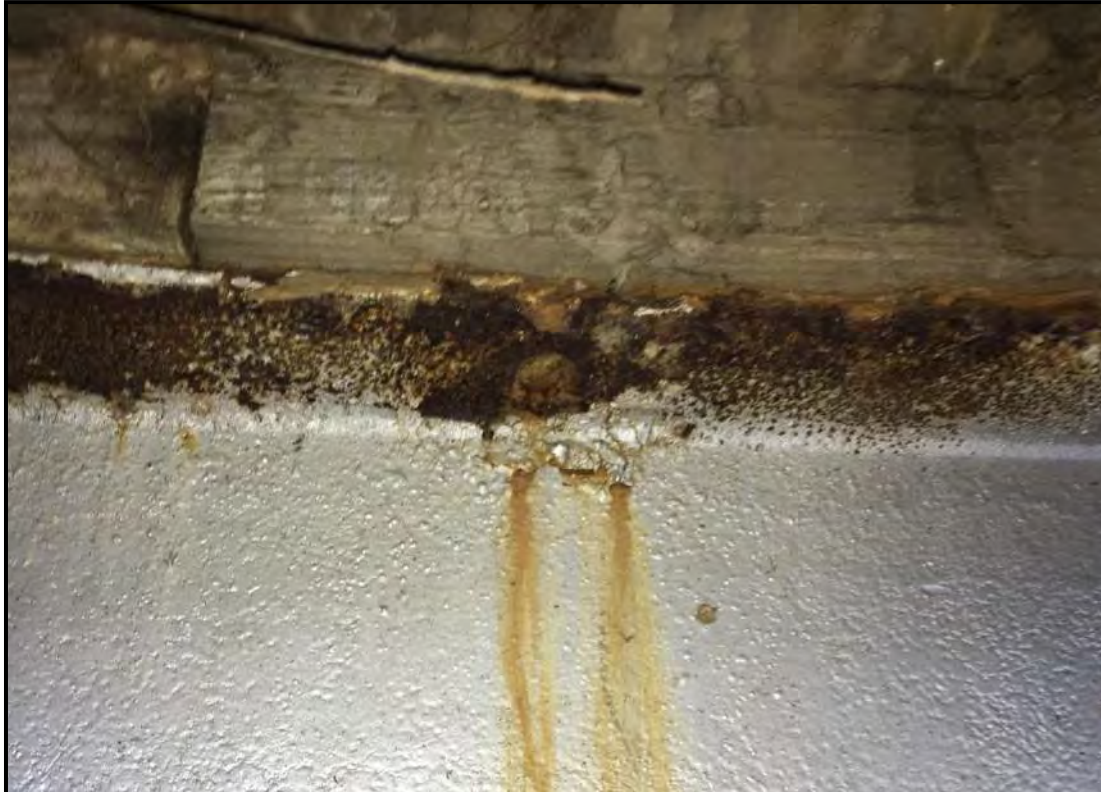
**Photograph 14:** Missing bolted connection and corroded top flange of bridge girder in Bay F.

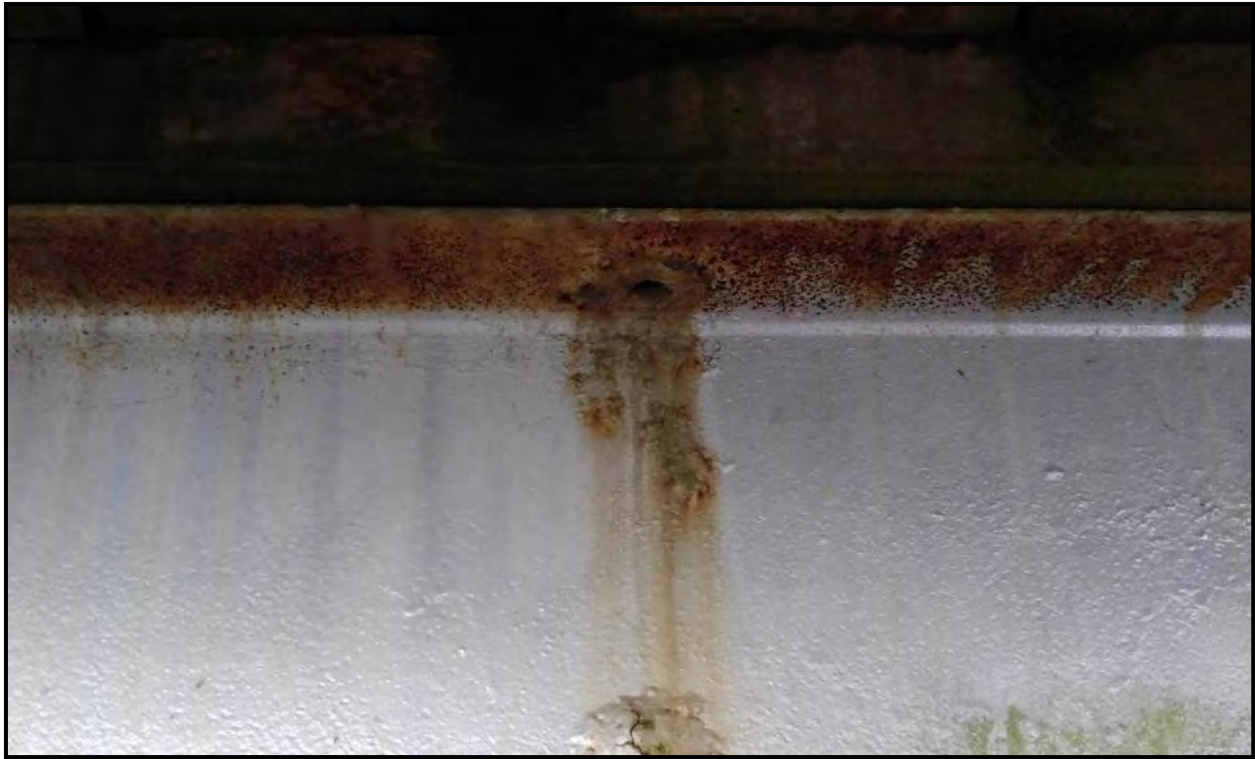
**Photograph 15:** Missing bolted connection and corroded top flange of bridge girder.

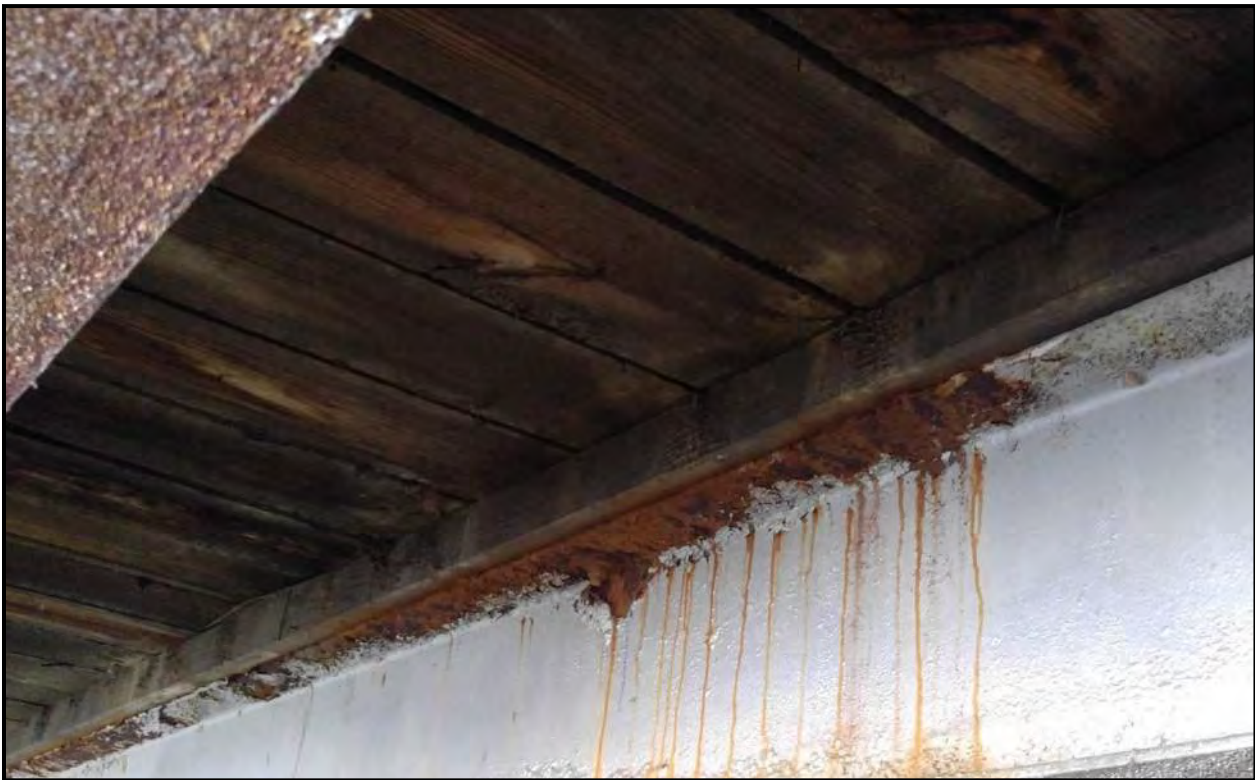
**Photograph 16:** Missing/Corroded bolted connection and corroded top flange of bridge girder.

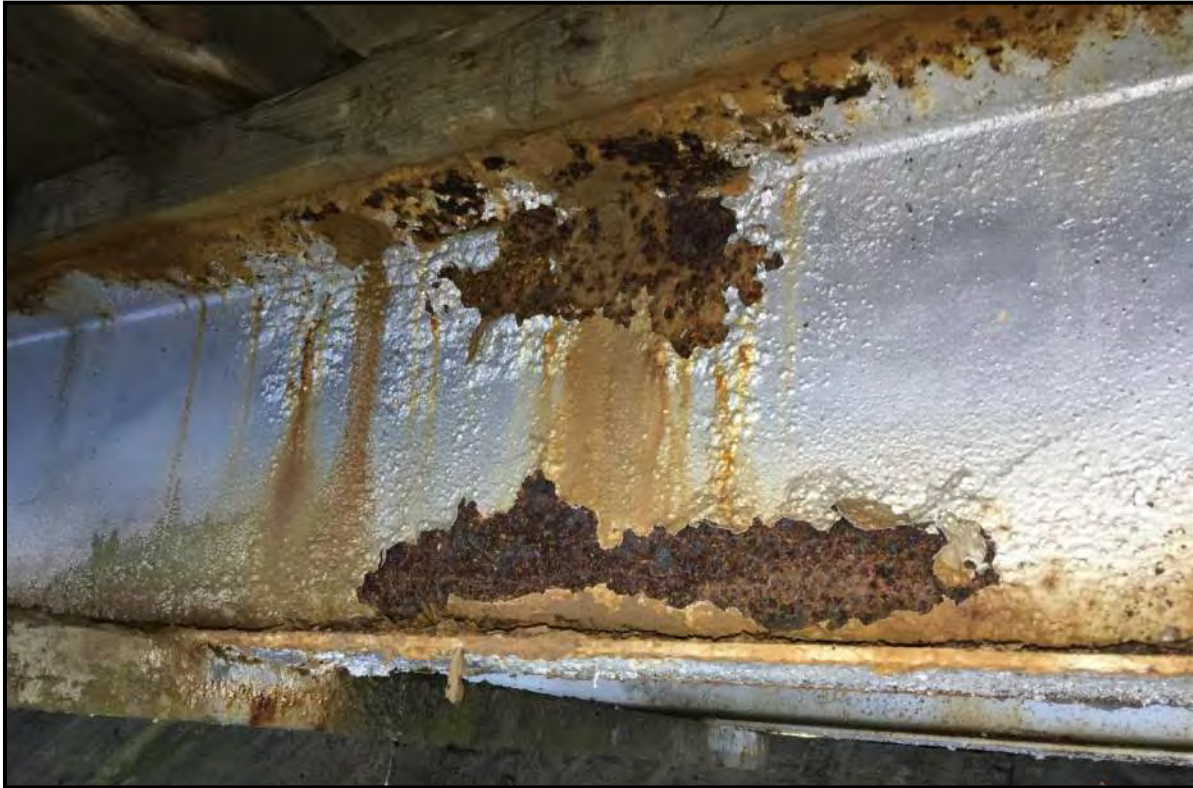
**Photograph 17:** Corrosion of bolted connection, top flange, and web of bridge girder in Bay B.

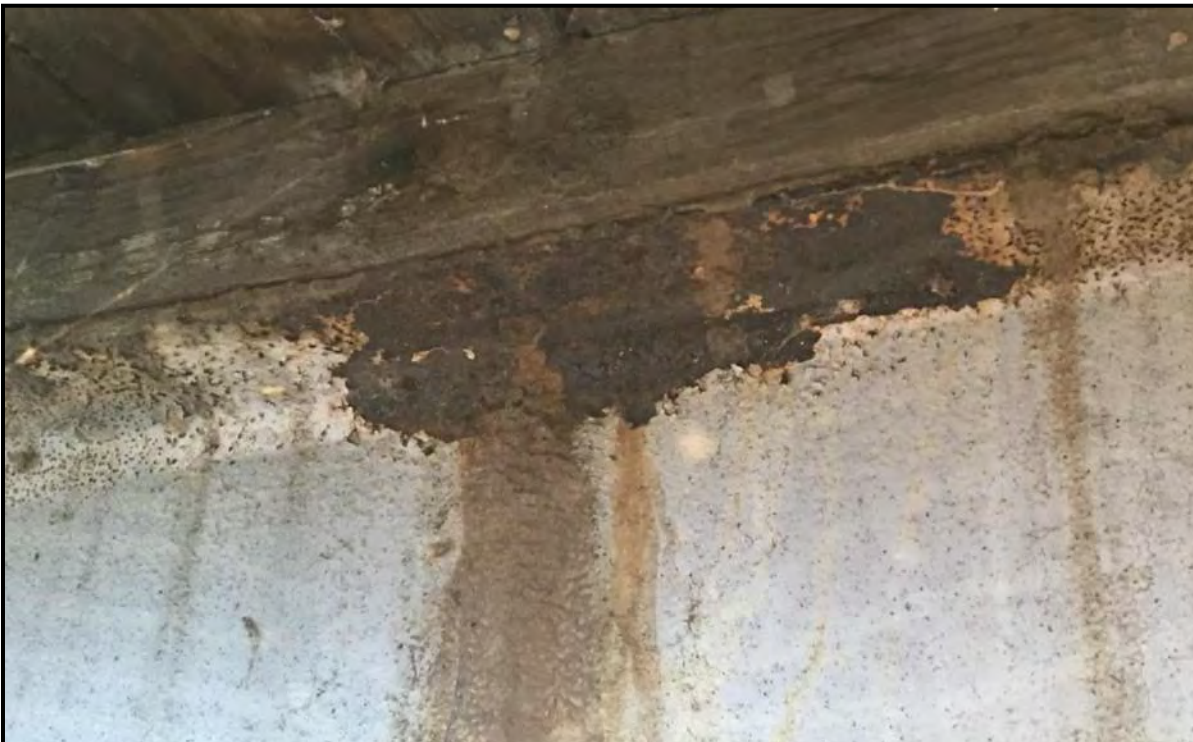
**Photograph 18:** Missing bolted connection and corrosion of top flange of bridge girder in Bay D.

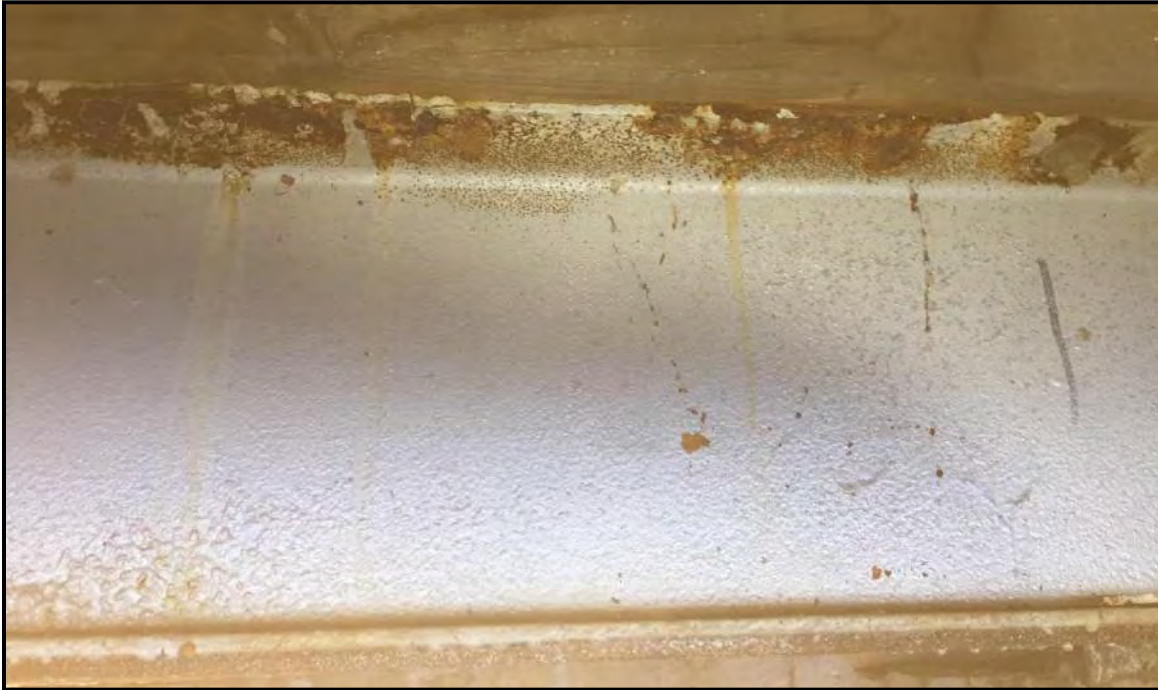
**Photograph 19:** Corrosion of bolted connection and top flange of bridge girder in Bay K.

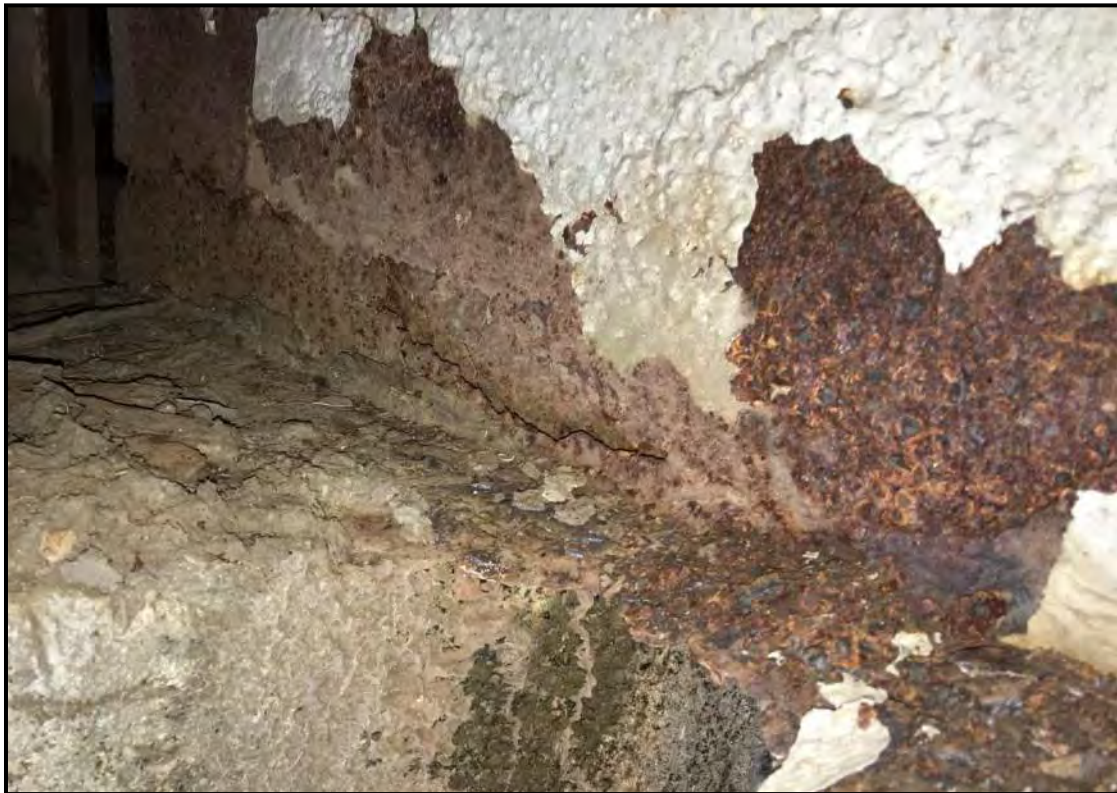
**Photograph 20:** Severe corrosion of web and bottom flange of bridge girder at Bay K – Bay L bearing location.

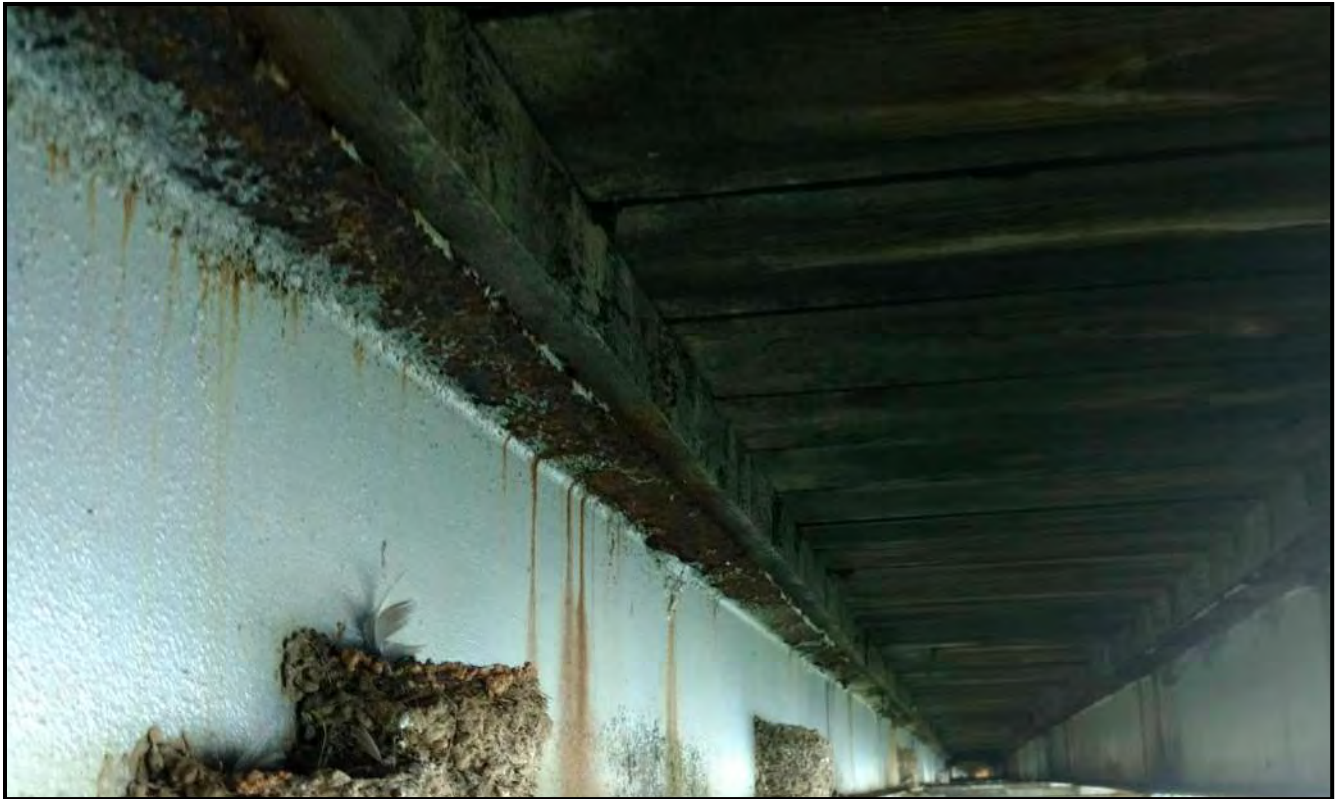
**Photograph 21:** Corrosion of top flange of bridge girder at Bay N.

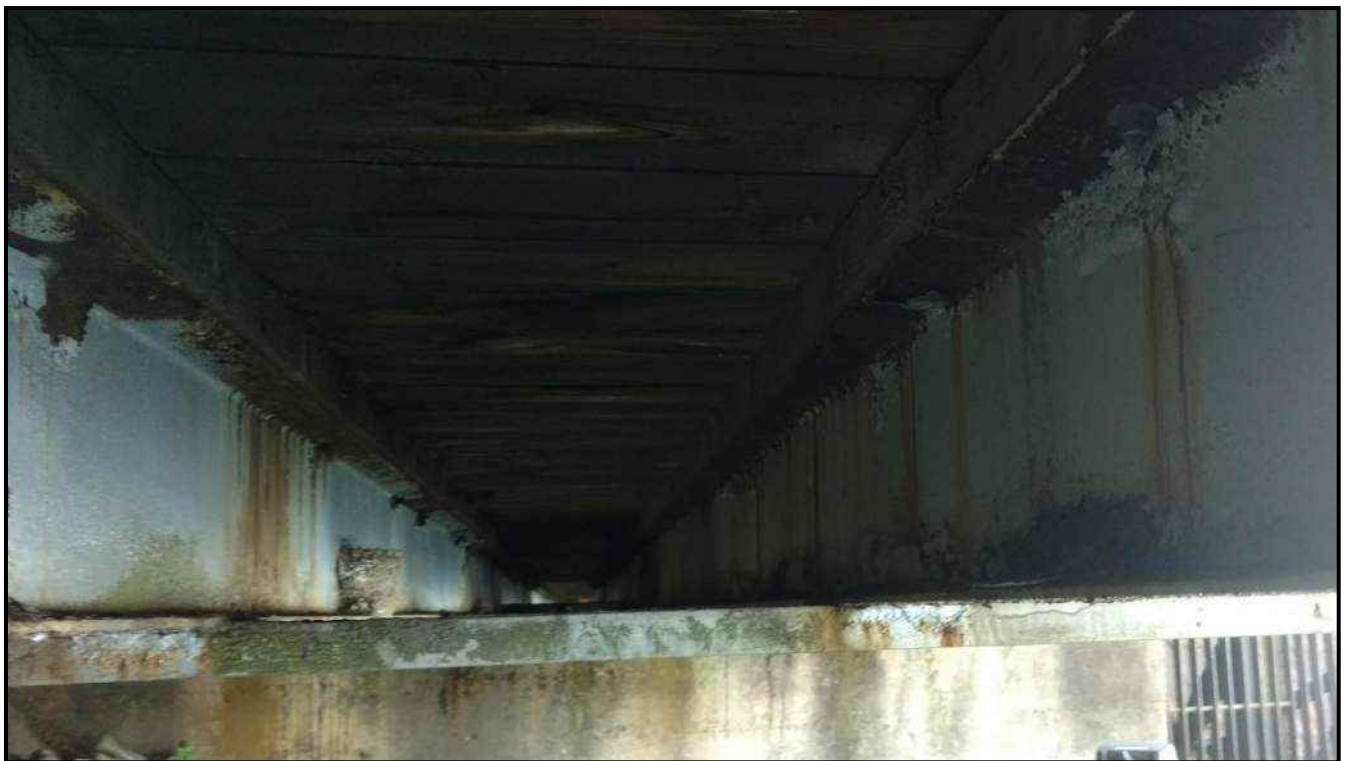
**Photograph 22:** Corrosion of bolted connections and top flanges of bridge girder at Bay M.

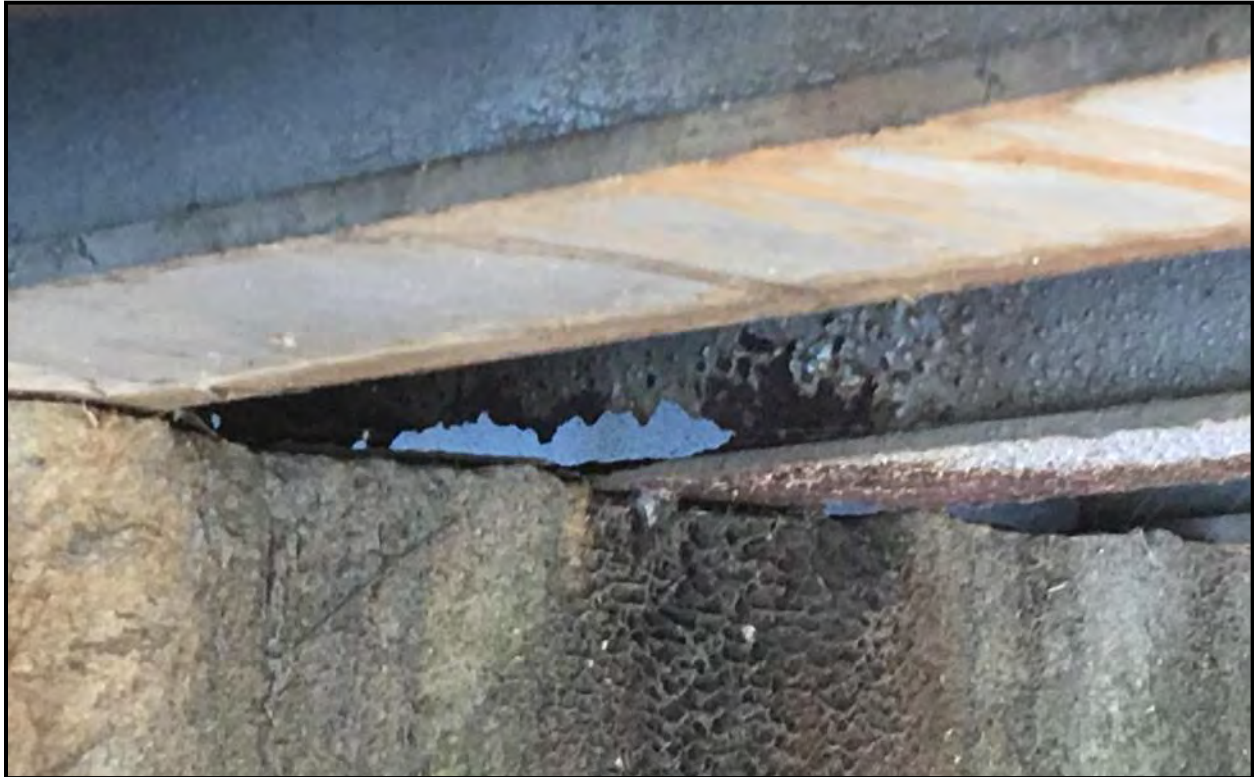
**Photograph 23:** Severe corrosion of web of bridge girder at Bay G-Bay H bearing. Supplemental girders added on either side in early 1990's. Supplemental girder shown in foreground.

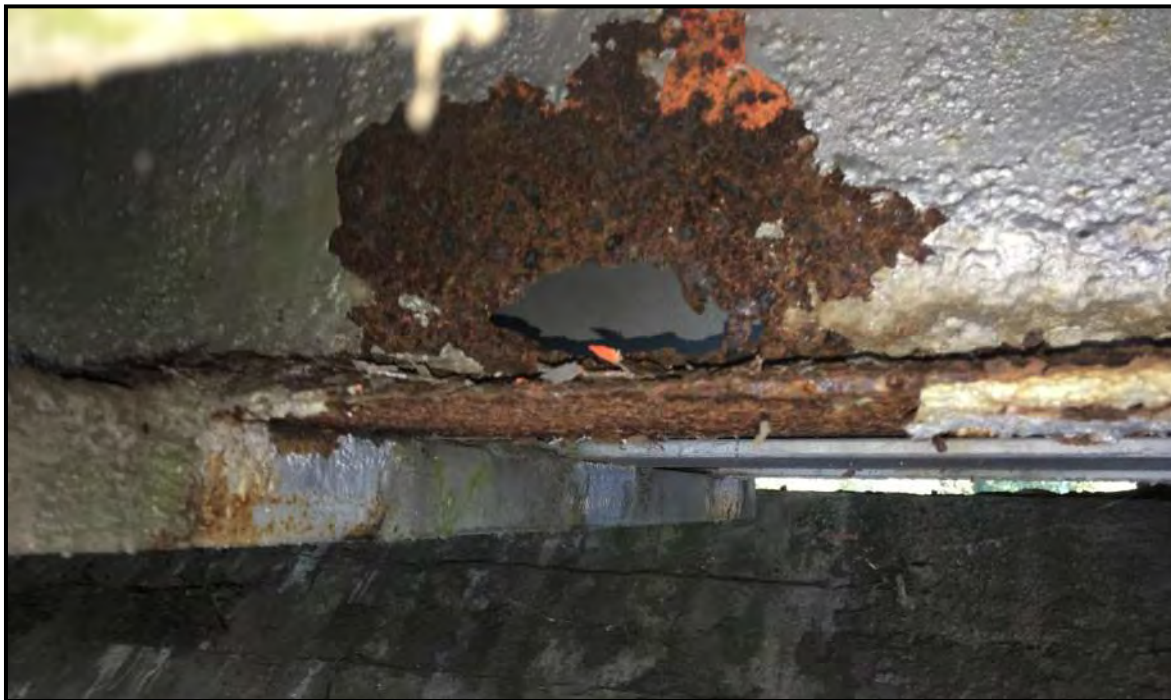
**Photograph 24:** Severe corrosion of web and bottom flange at mid-span of bridge girder in Bay O. Supplemental girders added on either side in early 1990's.
