**BUNNELL-LAMMONS ENGINEERING, INC.**  
GEOTECHNICAL, ENVIRONMENTAL AND CONSTRUCTION MATERIALS CONSULTANTS

# LAKE JUNALUSKA DAM BRIDGE EVALUATION

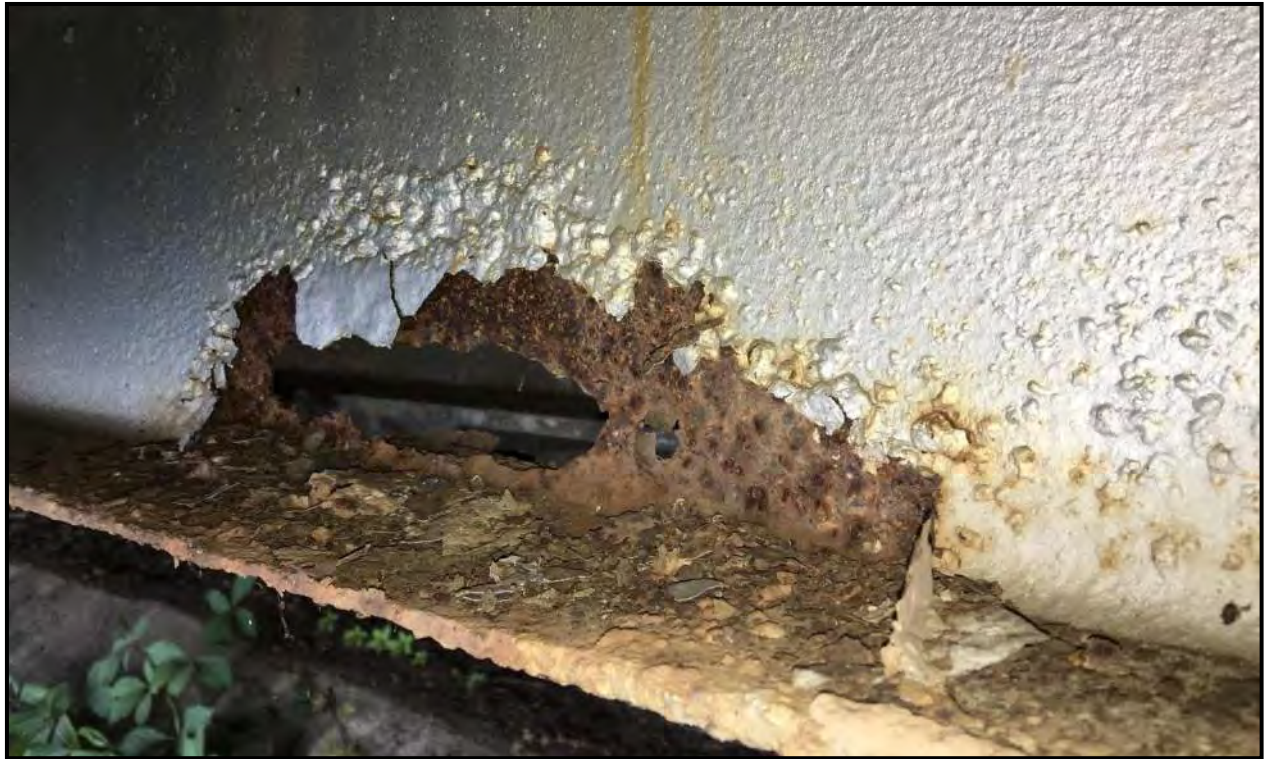
**Photograph 25:** Severe corrosion of web and bottom flange at mid-span of bridge girder in Bay Q. Supplemental girders added on either side in early 1990's.

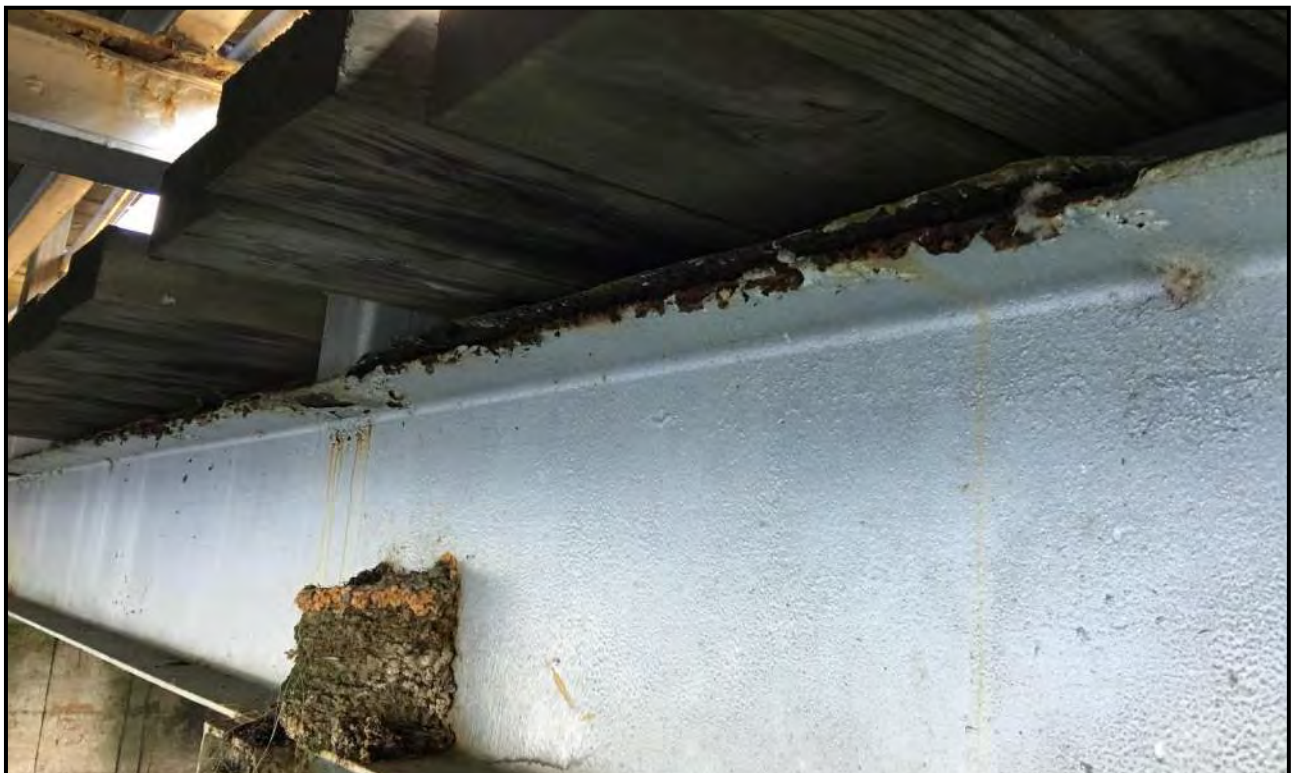
**Photograph 26:** Severe corrosion and delamination of top flange of bridge girder/post support beam in Bay C.

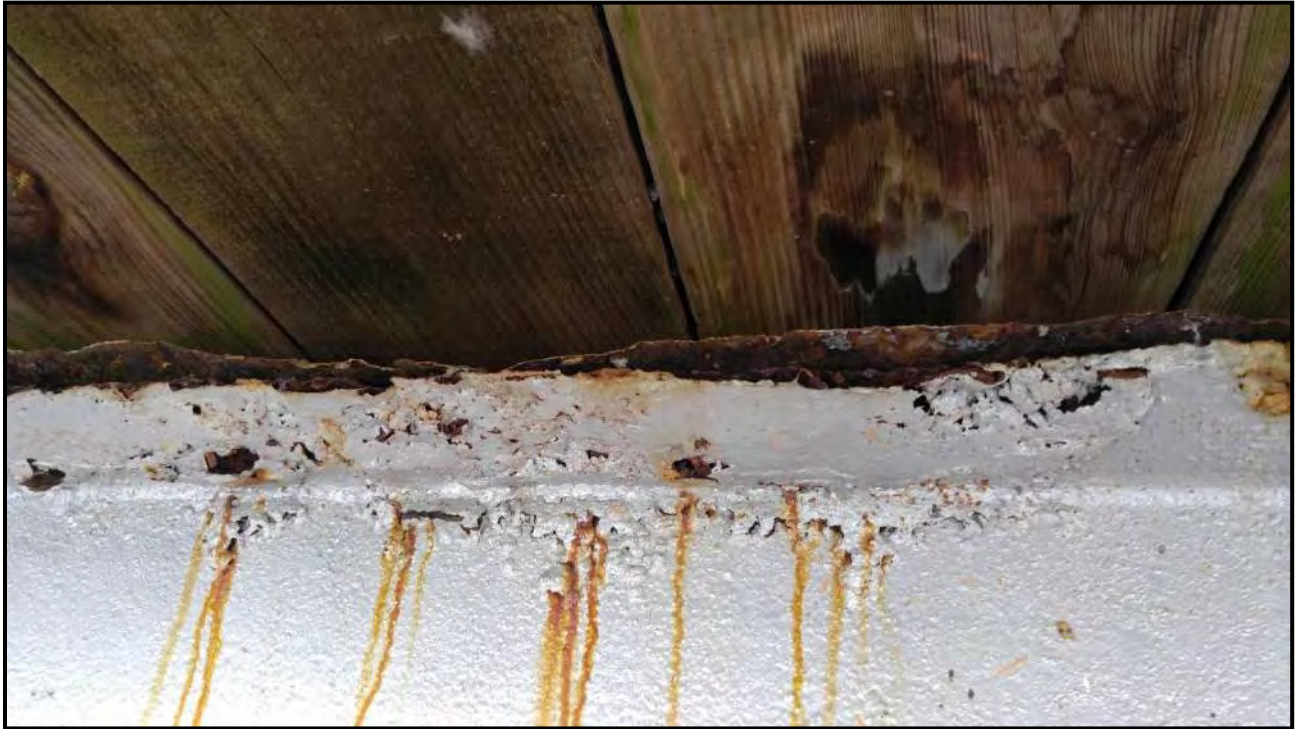
**Photograph 27:** Severe corrosion and delamination of top flange of bridge girder/post support beam in Bay M.

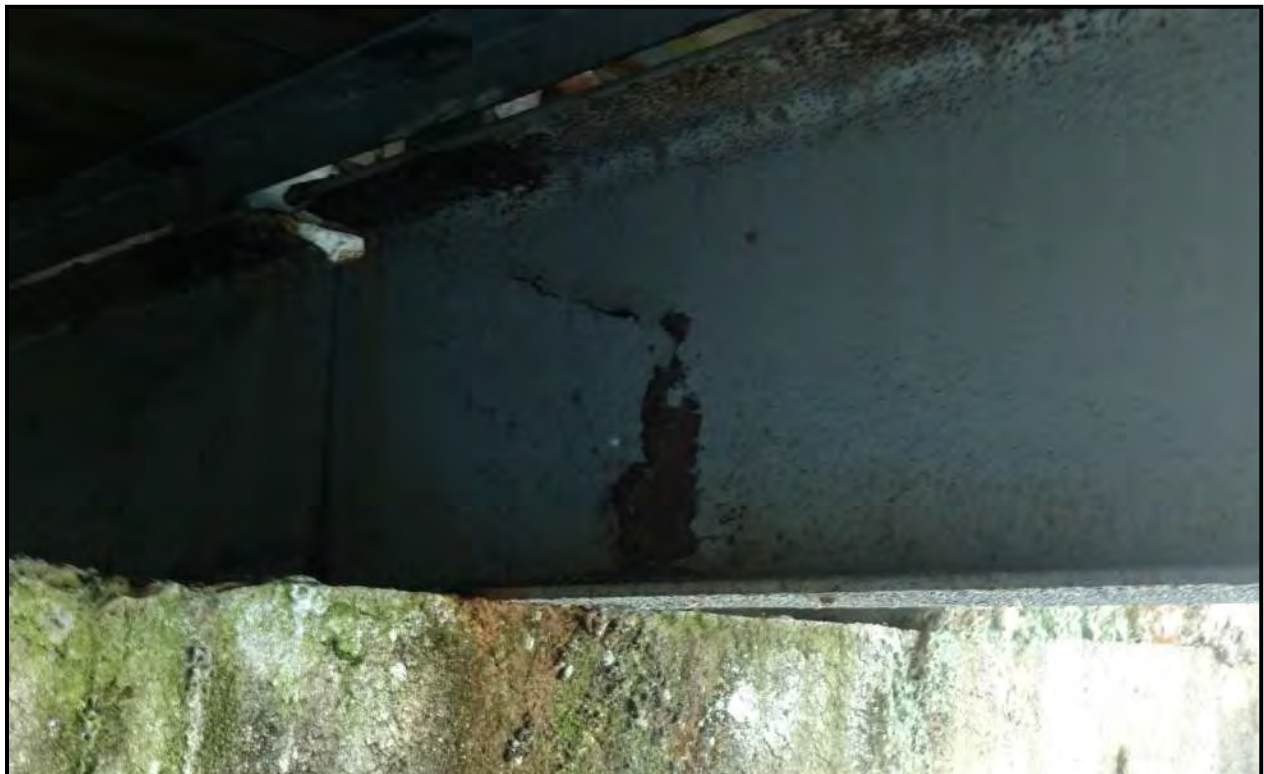
**Photograph 28:** Damage and corrosion at back side of weld for bridge girder connection plate typical at bridge girder connection plates.

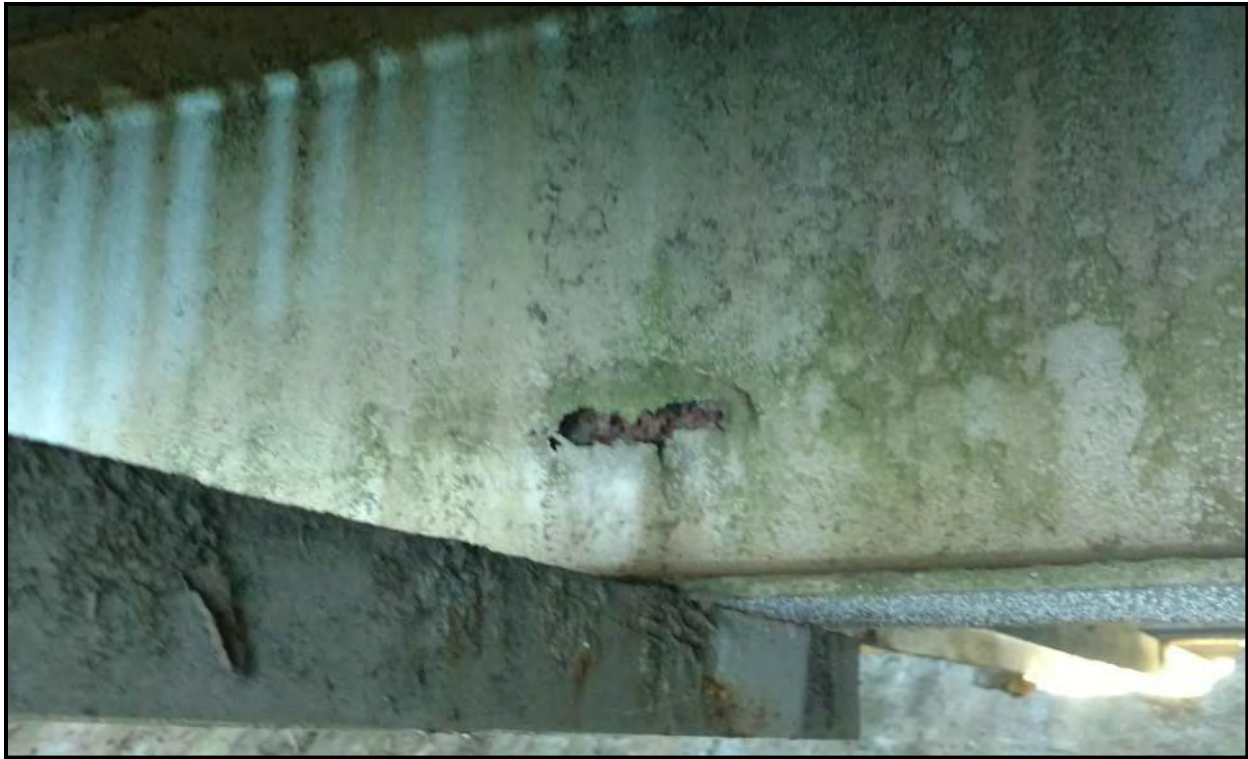
**Photograph 29:** Damage and corrosion at back side of weld for the lateral bracing member.

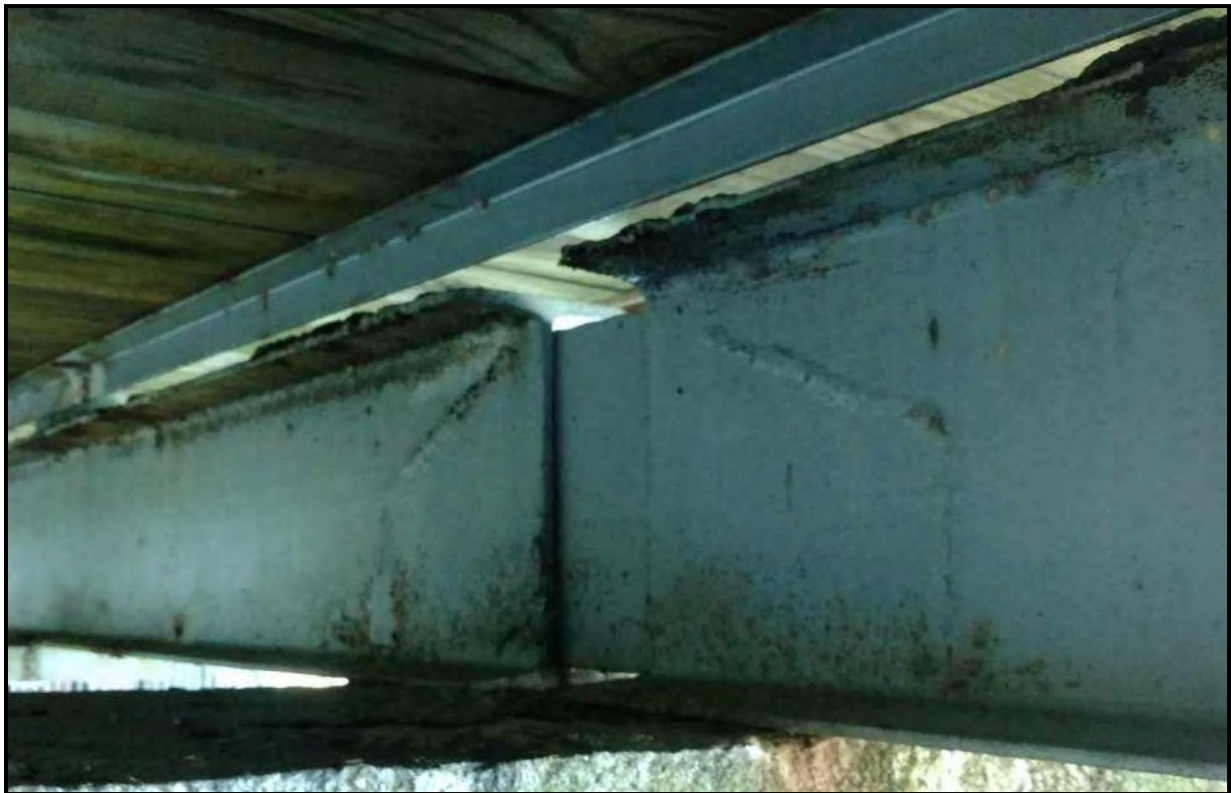
**Photograph 30:** Back side of typical bridge girder to bridge girder connection.

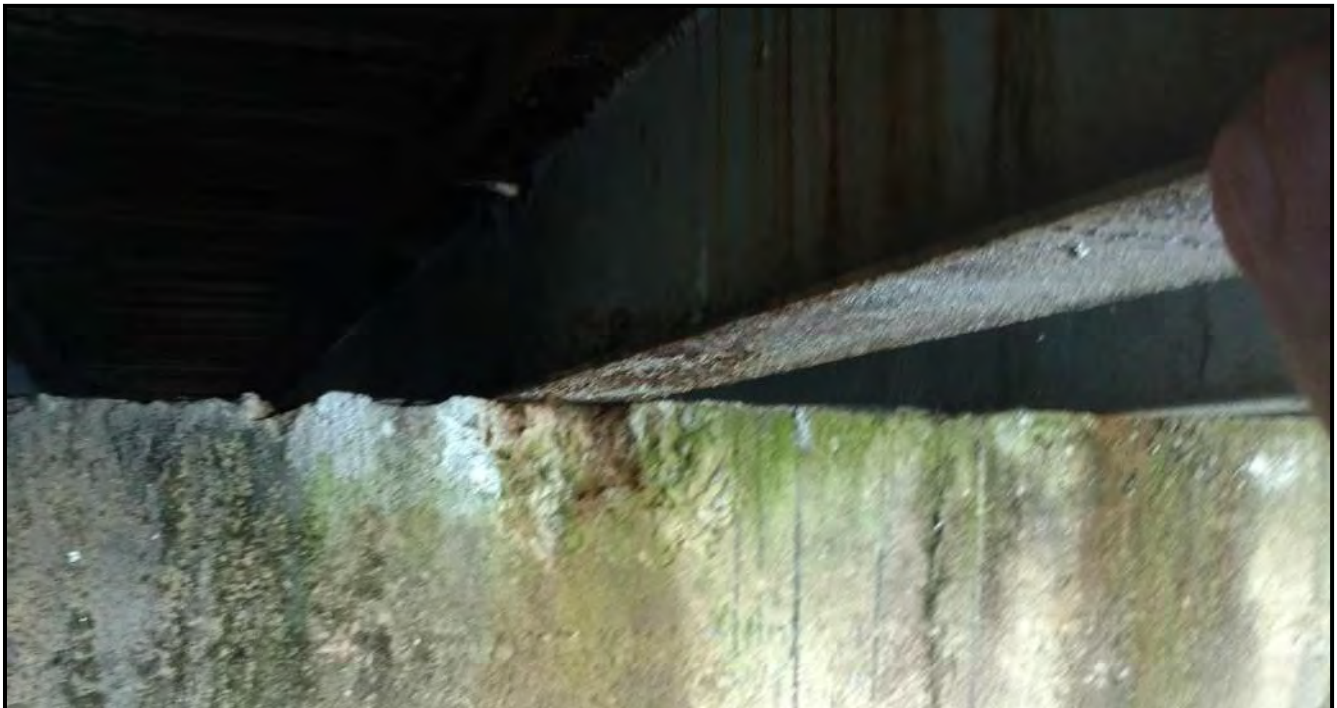
**Photograph 32:** Damage to concrete bridge abutment at Bay M – Bay L bridge girder bearing location.

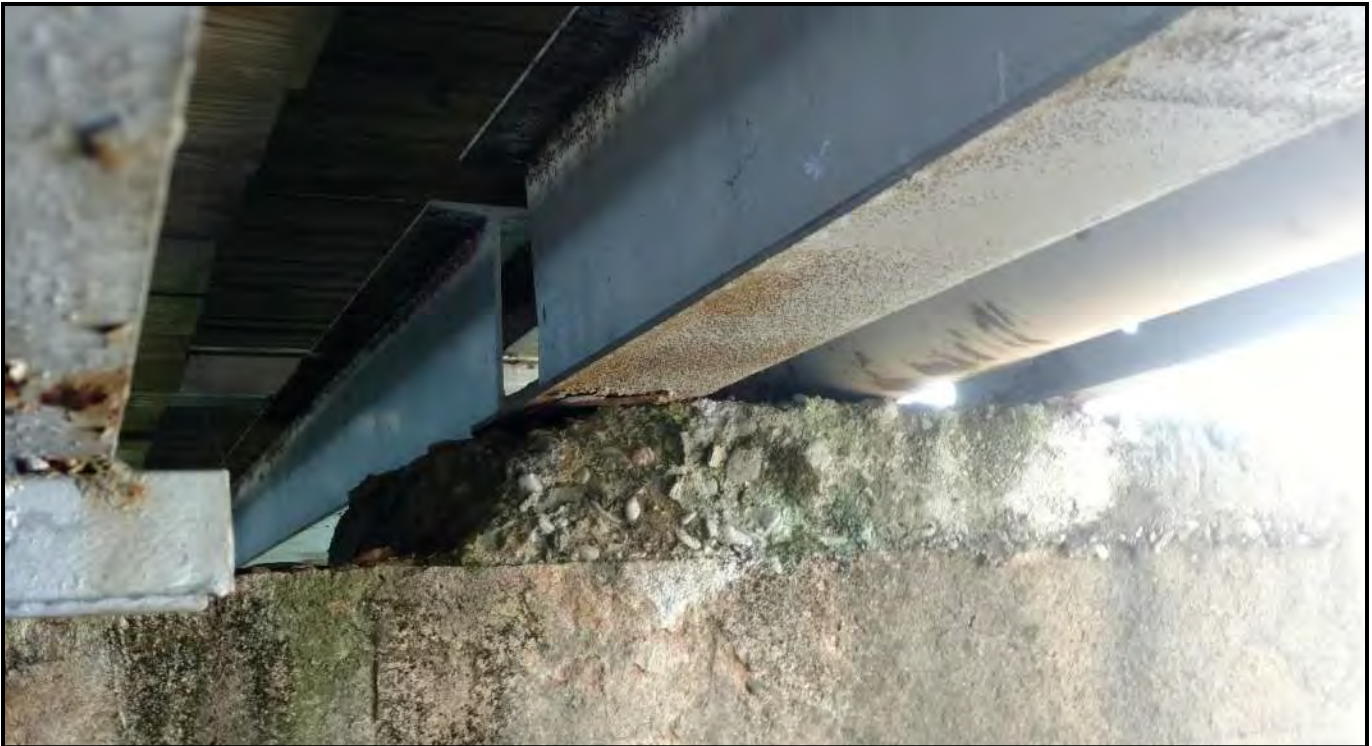
**Photograph 33:** Damage to built-up section of the concrete bridge abutment at bridge girder bearing location.

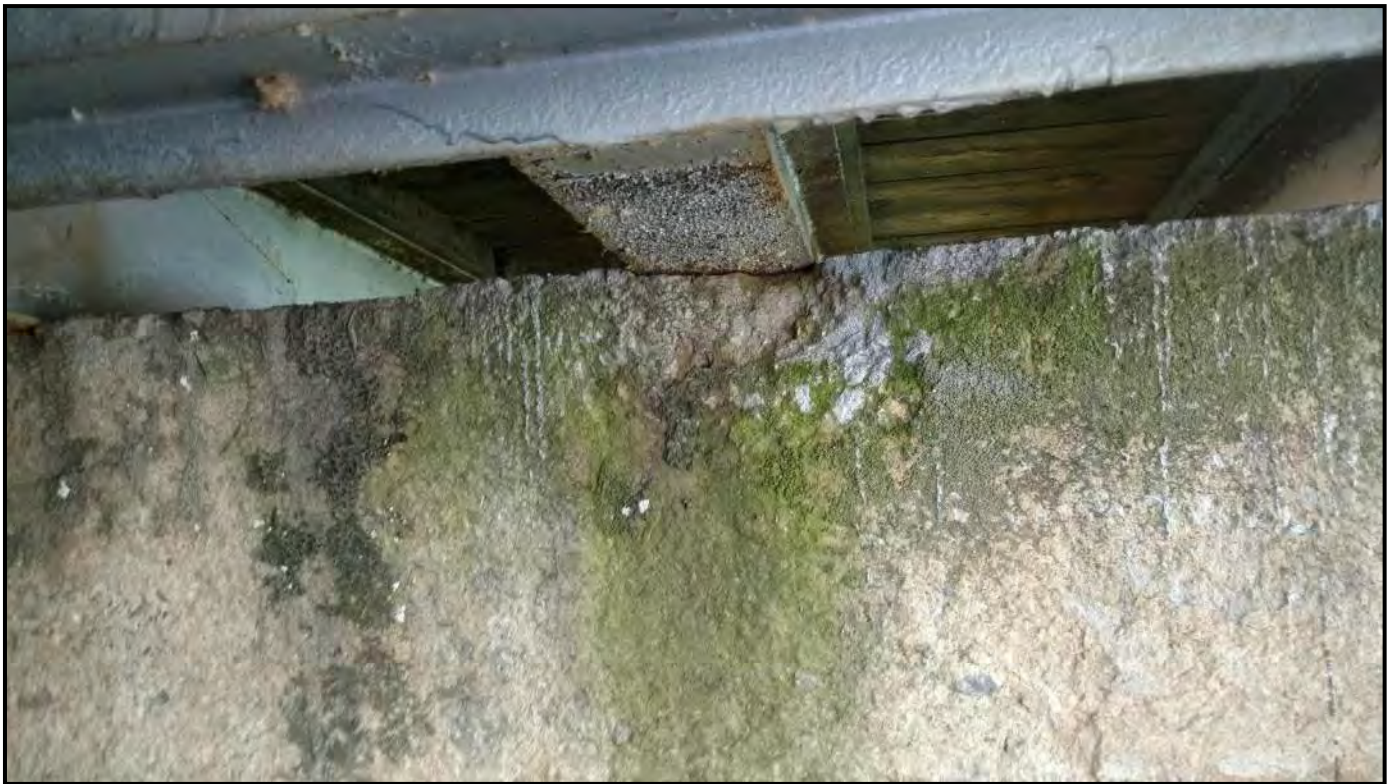
**Photograph 34:** Damage to the concrete bridge abutment at bridge girder bearing location.

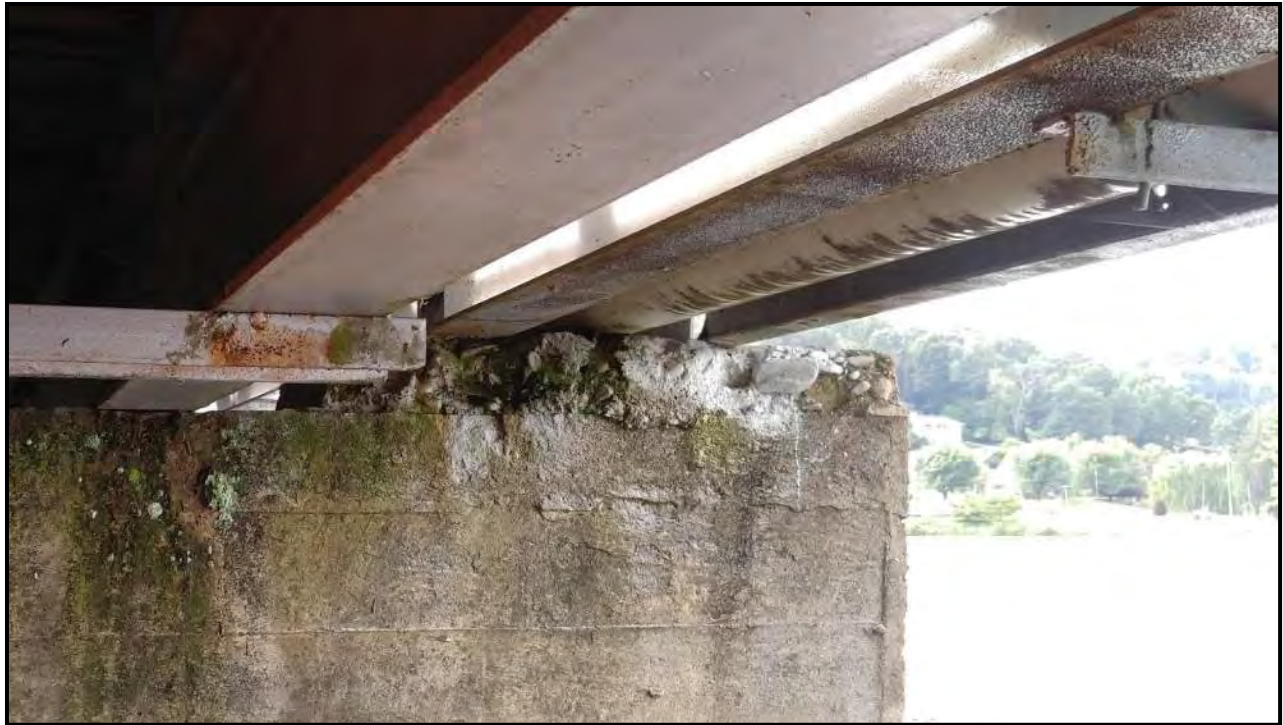
**Photograph 35:** Damage to built-up section of the concrete bridge abutment at bridge girder bearing location.

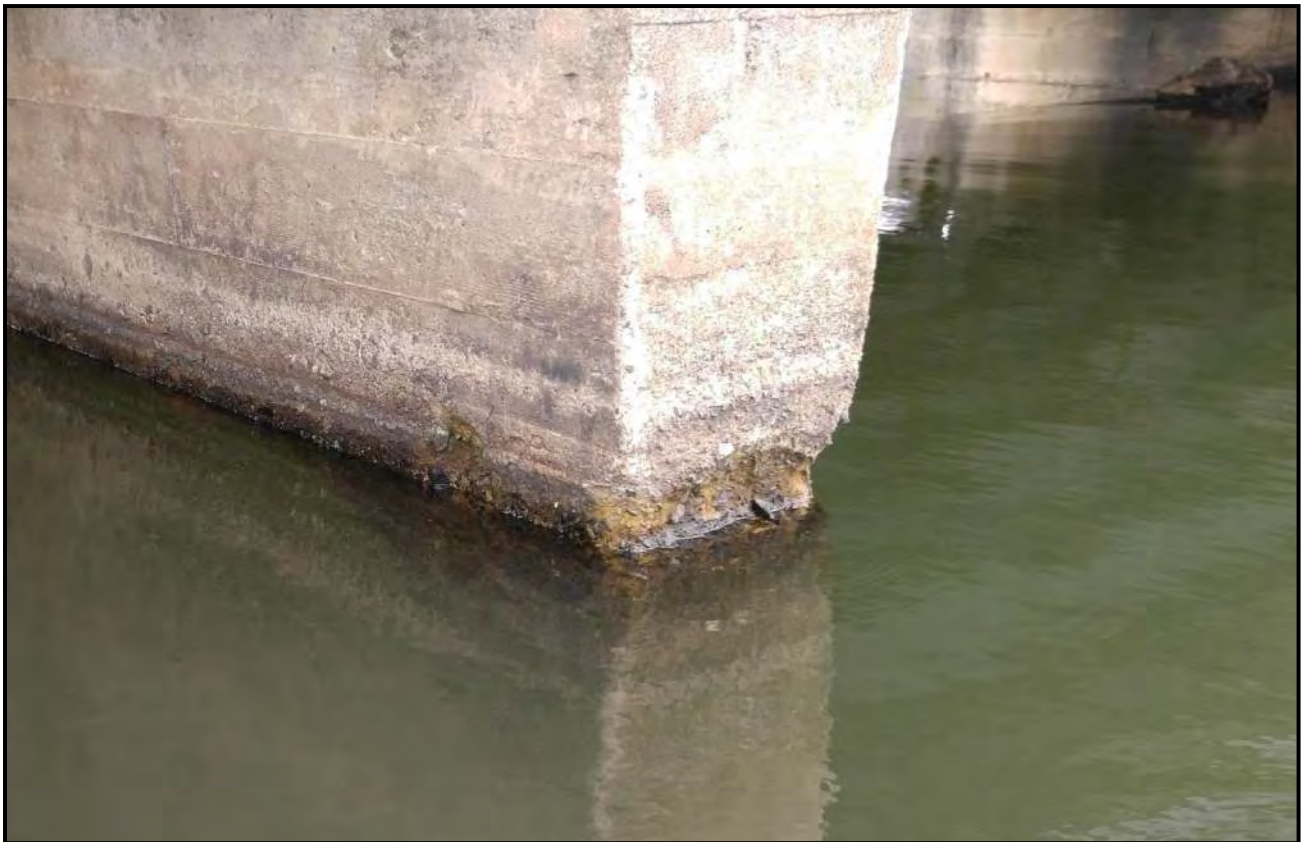
**Photograph 36:** Wearing of the concrete bridge abutment at the water level.

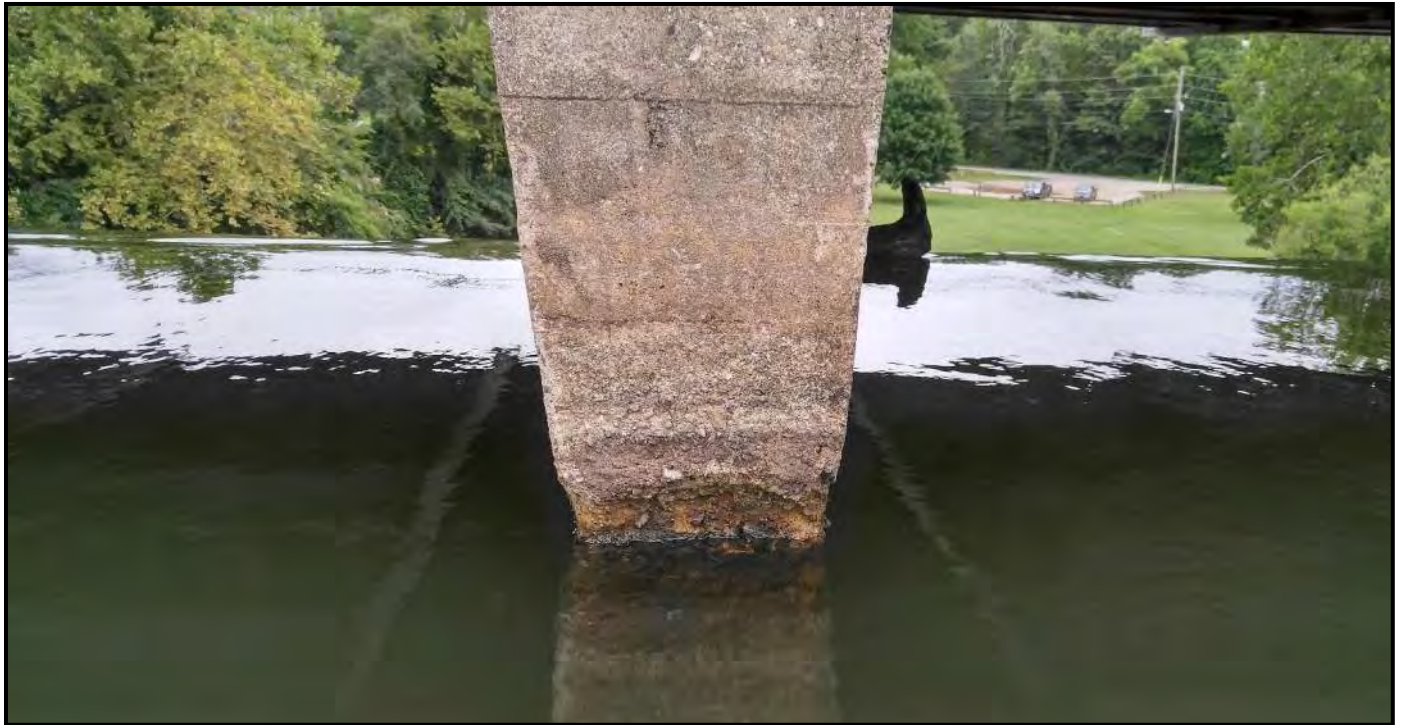
**Photograph 37:** Wearing of the concrete bridge abutment at the water level.

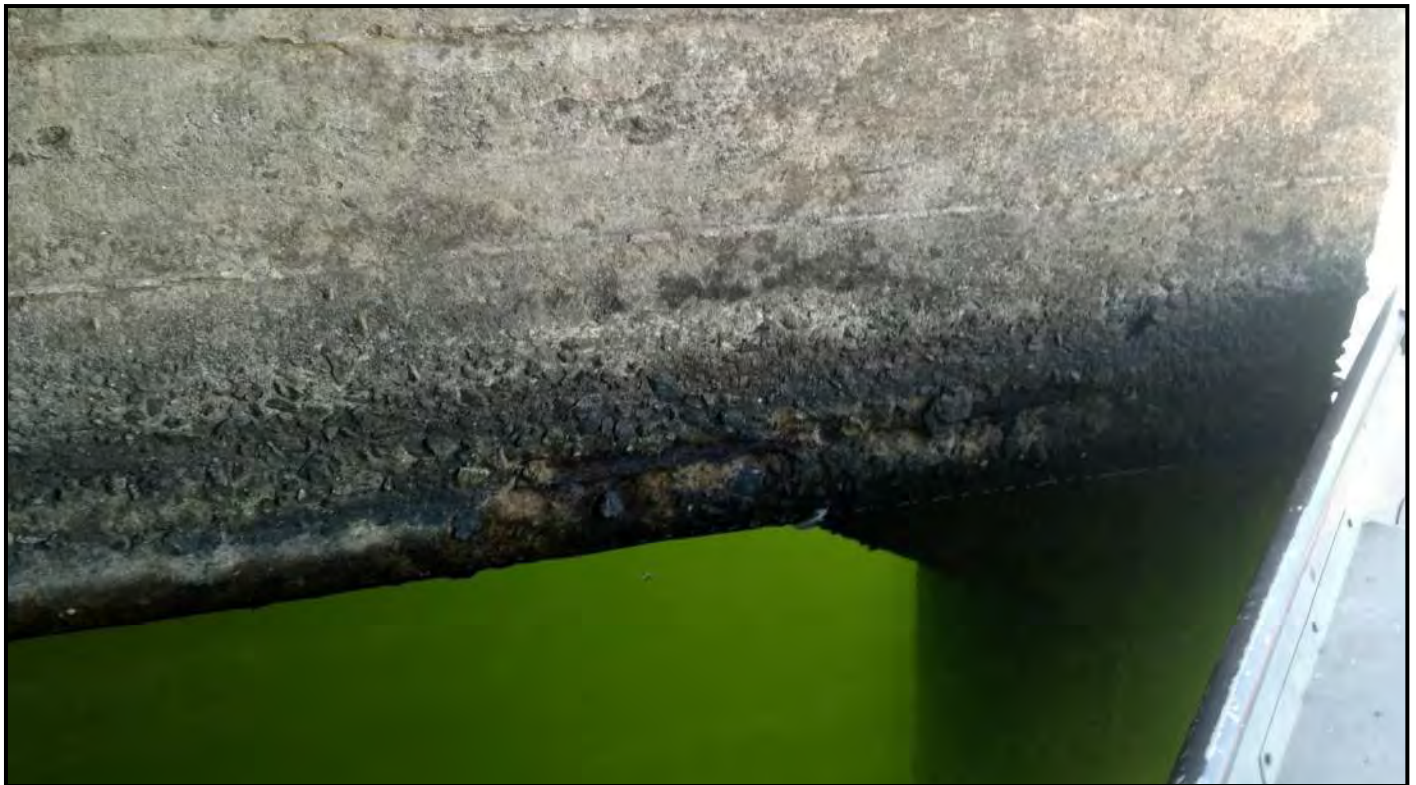
**Photograph 38:** Wearing of the concrete bridge abutment at the water level.

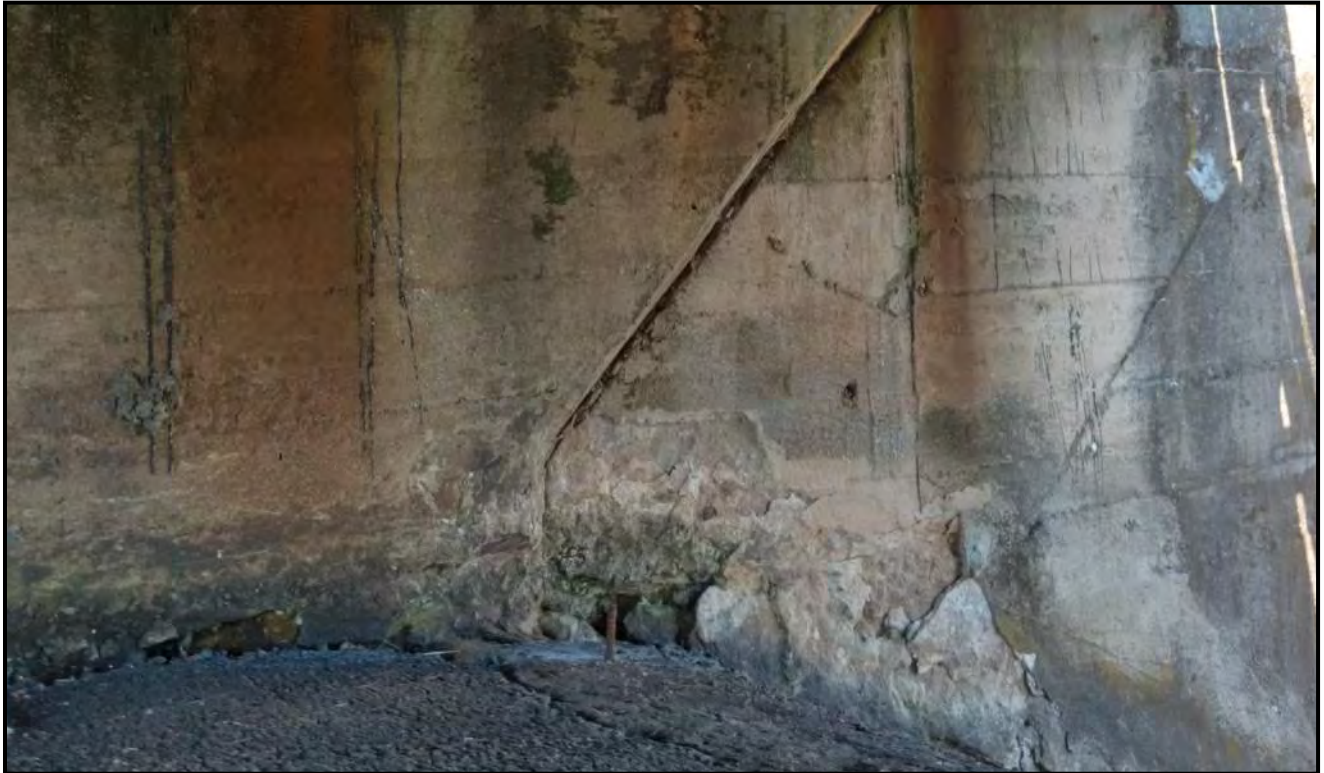
**Photograph 39:** Damage and spalling to the concrete bridge abutment between Bay J and Bay K at the interface with the spillway surface.

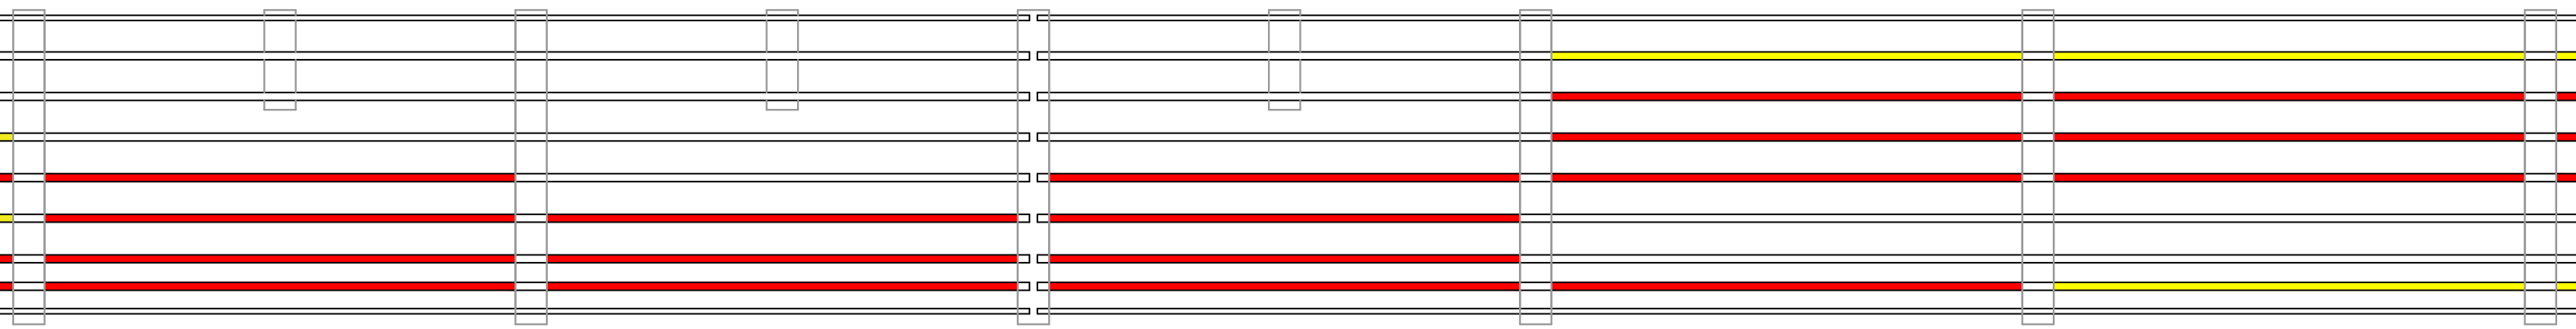
- STEEL MEMBER TO BE REMOVED
- STEEL MEMBER TO BE RE-INSPECTED
- ADDITIONAL AND/OR REPLACED STEEL MEMBER

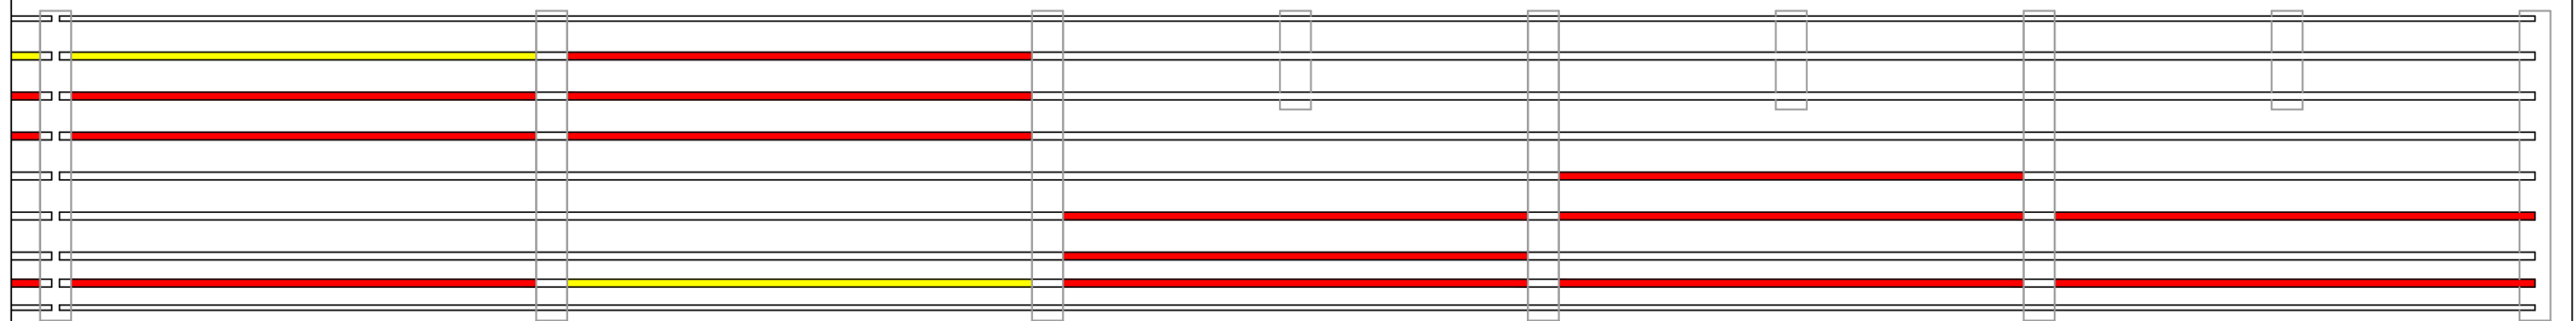
- STEEL MEMBER TO BE REMOVED
- STEEL MEMBER TO BE RE-INSPECTED
- ADDITIONAL AND/OR REPLACED STEEL MEMBER

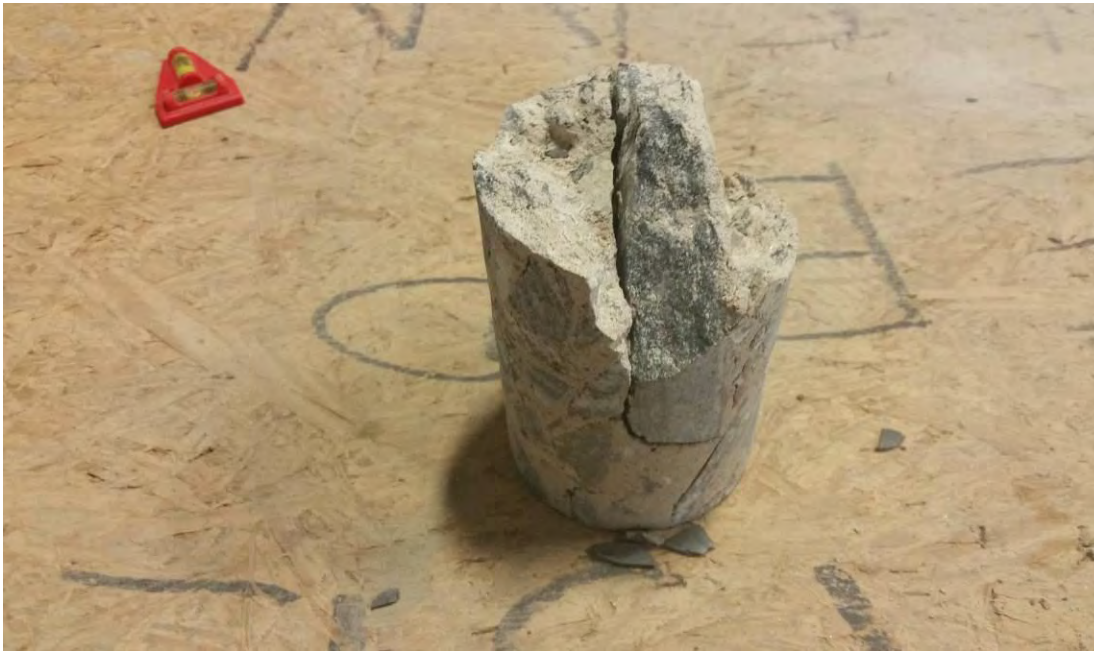
Date: 12/8/16
		Photographer: C. Sluder
<b>3</b>	<b>Location / Orientation</b>	Concrete Core from Abutment
	<b>Remarks</b>	Large aggregate shown with separation at cement.

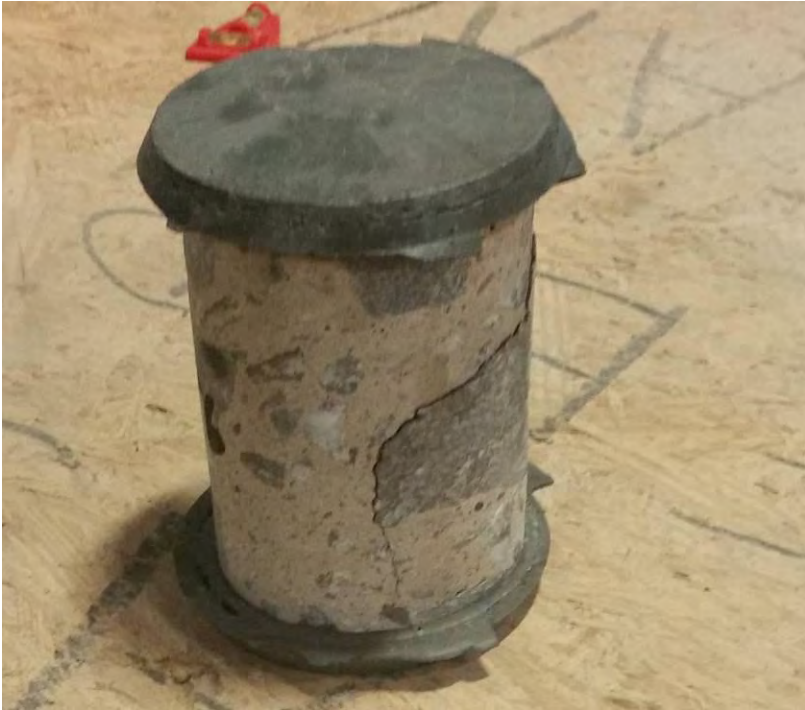
Date: 12/8/16
		Photographer: C. Sluder
<b>4</b>	<b>Location / Orientation</b>	Concrete Core #1
	<b>Remarks</b>	Concrete failure at edge of large aggregate.

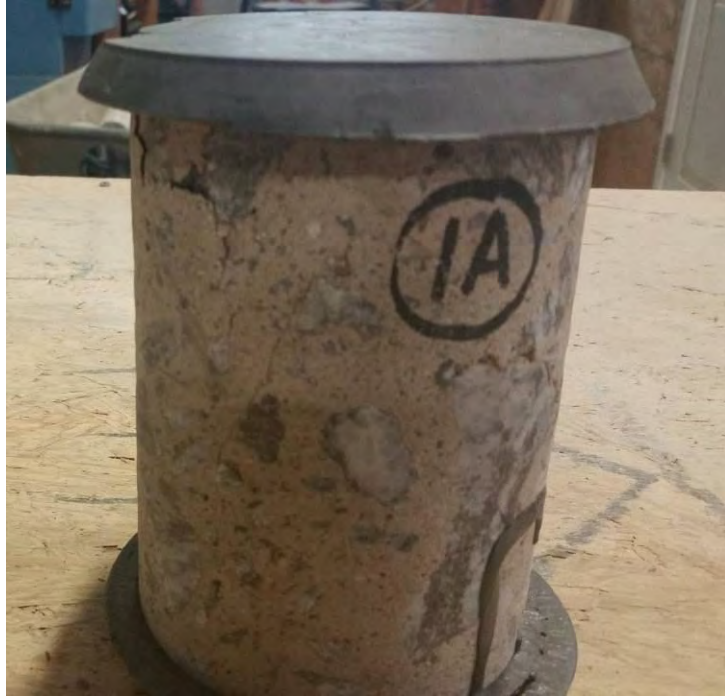
<b>6</b>	<b>Location / Orientation</b>	Concrete Core #2	Date: 12/8/16  Photographer: C. Sluder
	<b>Remarks</b>	Concrete failure Type 2

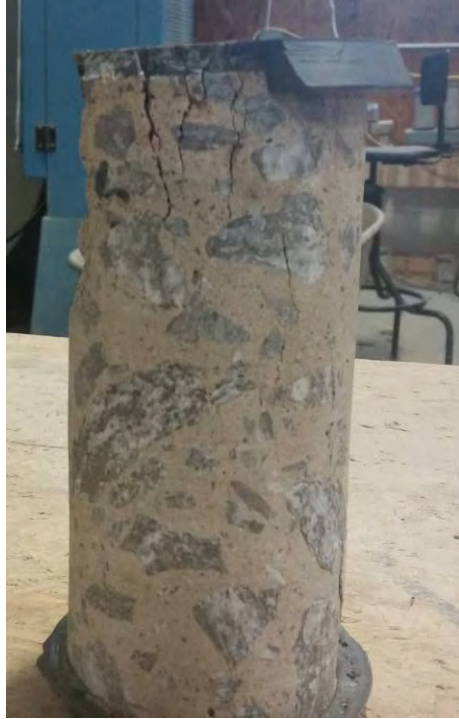
<b>7</b>	<b>Location / Orientation</b>	Concrete Core #3	Date: 12/8/16  Photographer: C. Sluder
	<b>Remarks</b>	Fractures along aggregate

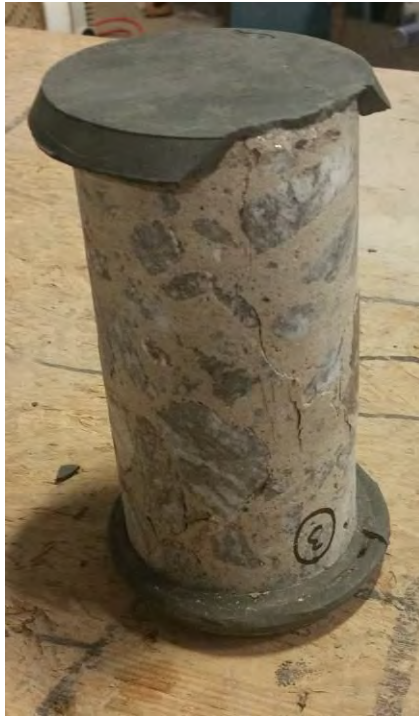
<b>8</b>	<b>Location / Orientation</b>	Concrete Core #4	Date: 12/8/16  Photographer: C. Sluder
	<b>Remarks</b>	Concrete failure Type 1

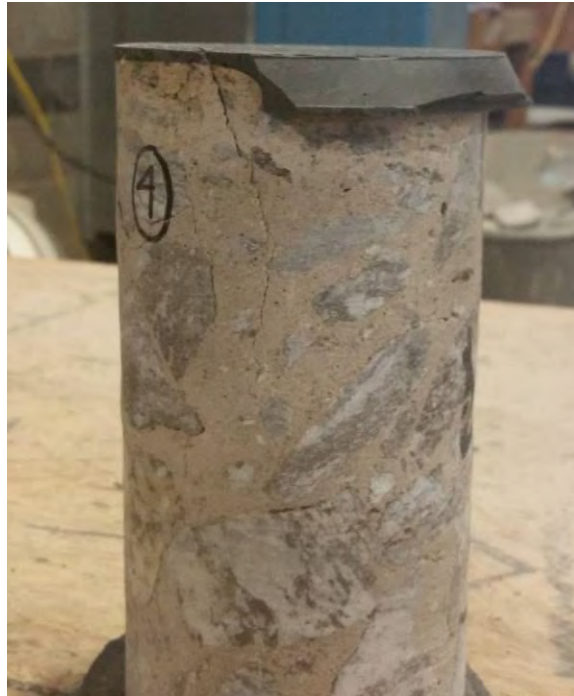
<b>9</b>	<b>Location / Orientation</b>	Concrete Core #5	Date: 12/8/16  Photographer: C. Sluder
	<b>Remarks</b>	Fractures along aggregate.

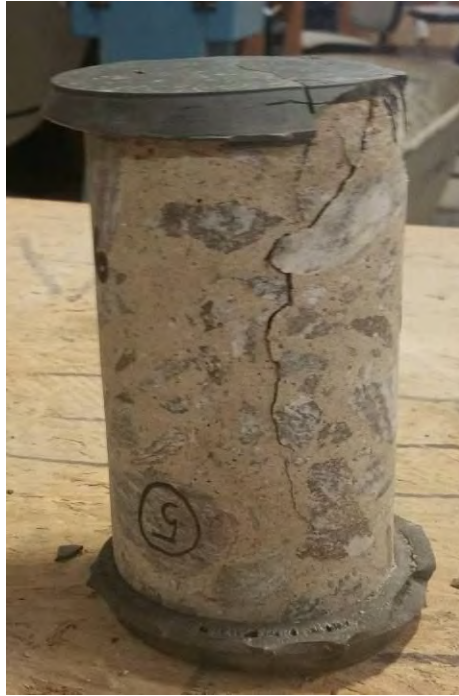
<b>10</b>	<b>Location / Orientation</b>	Concrete Core #6	Date: 12/8/16  Photographer: C. Sluder
	<b>Remarks</b>	Concrete failure Type 2

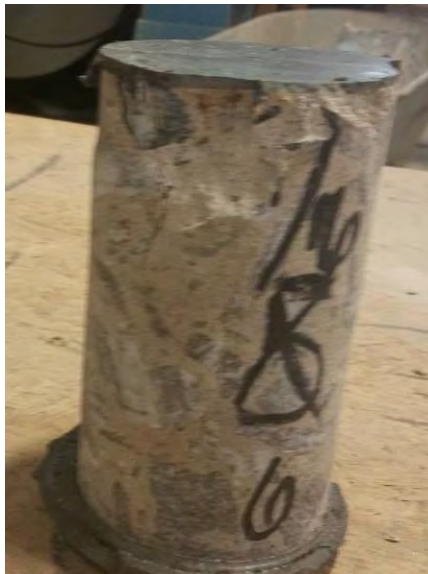
<b>11</b>	<b>Location / Orientation</b>	Concrete Core #7	Date: 12/8/16  Photographer: C. Sluder
	<b>Remarks</b>	Concrete failure Type 1

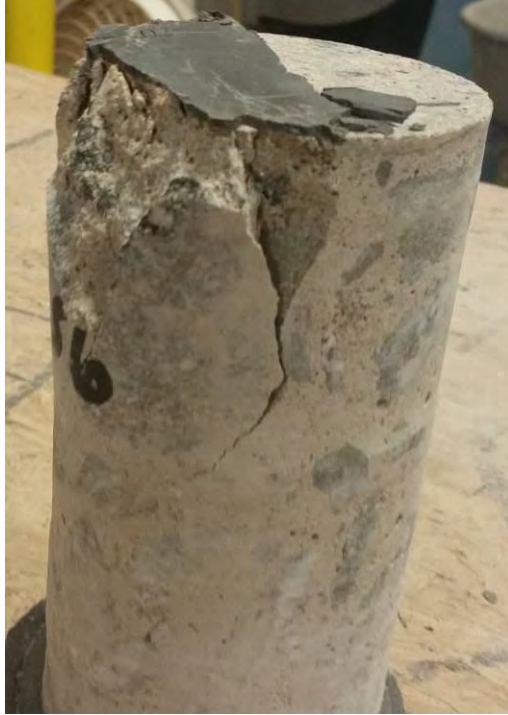
<b>12</b>	<b>Location / Orientation</b>	Concrete Core #8	Date: 12/8/16  Photographer: C. Sluder
	<b>Remarks</b>	Fractures along aggregate
